Air Entrapment Issues in Piping for a Small Hydroelectric Station in Western North Carolina

Air entrapment issues in piping for a small hydroelectric station in western North Carolina

Abstract-A team from Western Carolina University's Rapid Center in Cullowhee, North Carolina visited a local fish farm to determine why a previously installed stream-powered, electricity generating system was not working correctly. The team met the owner and a local Agricultural Extension Office Manager (AEOM), at the site. The AEOM provided the team with a tour of the primary structures and equipment.

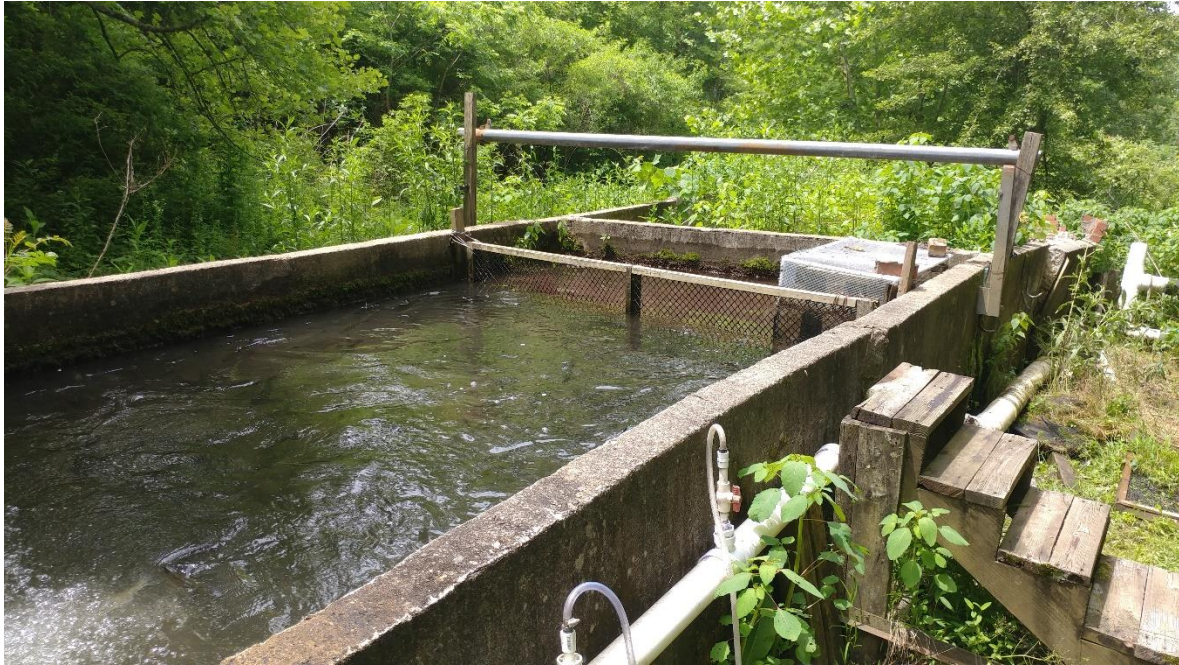
Figure 1

The team inspected the length of the pipeline and found several issues of concern. First, the pipe inlet suction structure was not totally flooded. It appeared that air could be introduced into the pipeline through the suction opening. Figure 1, below, shows the inlet structure. It is an open concrete tank holding live trout in one end and housing the suction line (shown in Figure 2) at the other end.

The water level above the suction line did not appear to be sufficient. A fitting was installed to the overflow pipe to increase the water level in the tank and appeared to reduce or eliminate the eddies observed at the pipeline inlet. The inlet screens were fouled significantly and were cleaned further improving the suction line condition. There was also a “bypass” piping

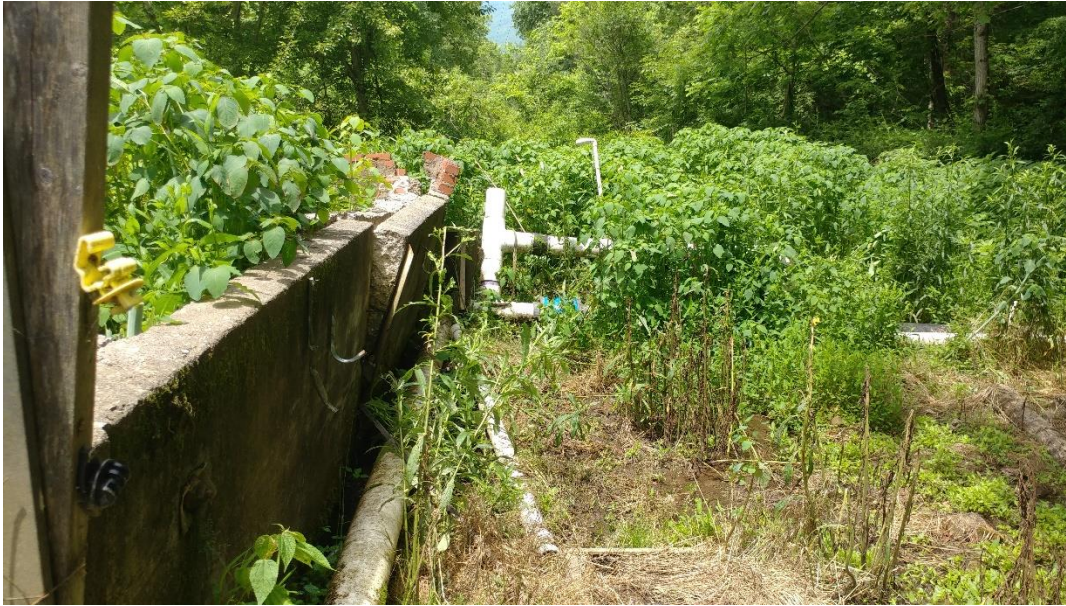
Figure 3

arrangement connecting the system pipeline which could potentially allow air infiltration to the system pipeline, see Figure 3. Fittings and tools were not available to modify this bypass piping.

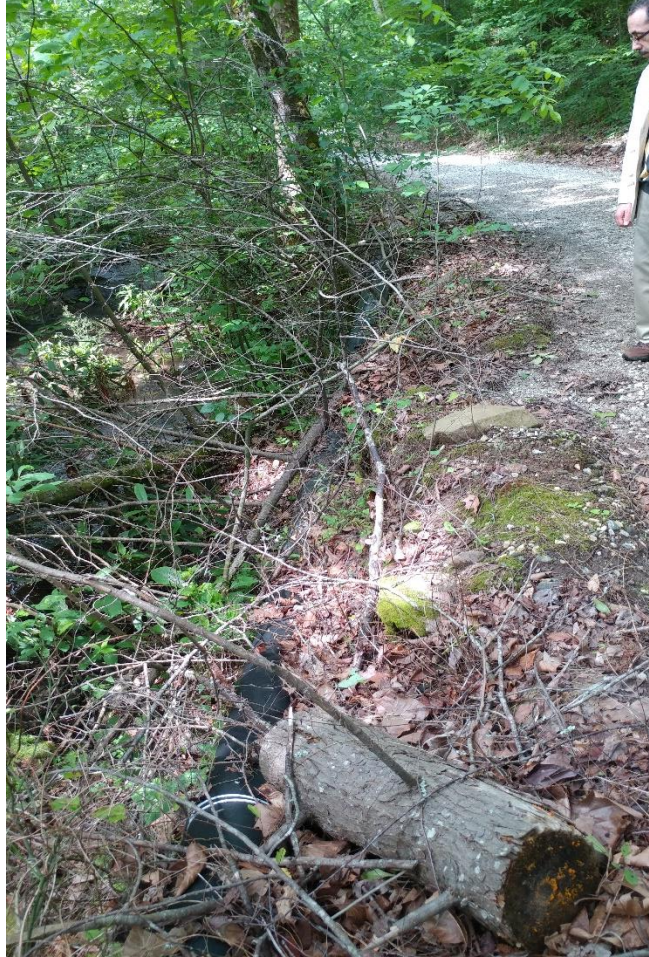
Figure 4

The system pipeline was flooded, and static pressure readings were taken at the turbine building. The expected static pressure, considering the 98 feet of head was 42.2 psig. The actual reading was 22 psig. The team discussed the static pressure issue and inspected the pipeline, finding two sections were not flooded with water, even after waiting a period for the pipeline to fill under a no turbine flow condition. There were no significant leaks, but there were sections of pipe which had slipped off their supports allowing significant elevation changes in the supply piping.

Since no major leaks were detected, air entrapment was considered the culprit of the low supply pressure. The sections of the pipeline which were out of position could trap air on the downhill side of the “loop”, see Figure 4.

2. The suction line at the turbines was inspected to ensure that there were no obstructions to flooding the turbine inlets.
3. The pipeline was reset to ensure uniform elevation drop in the pipeline to allow air to be vented. One would expect air to rise into the highest point in a pipe, but the sagging loops were trapping water.
