# Marine Icing on a Commercial Crabbing Vessel in the Gulf of Alaska: Accident Study

#### Abstract

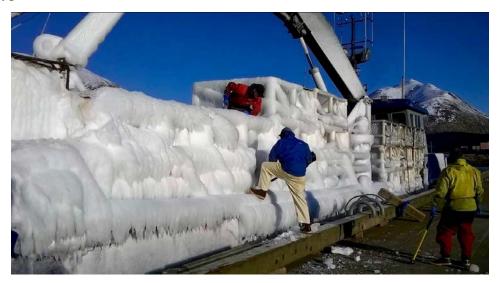
Figure 3 shows a commercial fishing vessel loaded with crab pots under similar icing scenarios as *Destination*. Ice build-up is more apparent on the stern of the vessel than the forward sections, indicating the non-uniform nature of sea-icing phenomenon. Ice can also be seen on the interior portions of the crab pots. Expert testimony from a panel of Naval Architects during the *Scandies Rose* Marine Board of Investigation (MBI) also attested to the non-uniform nature of ice and subsequent weight build up associated with sea-icing events [2]. It is also clear from this photo that the thickness of ice is much greater than the most severe icing events required to be analyzed by 46 CFR 28.550 and IS Code. IS Code also states, "For vessels operating where ice accretion may be expected... ice accretion requirements of one-half to twice the required allowance may be applied" (IS Code 6.3.2.6). Multiple masters of fishing vessels operating in and around the time of *Destination*'s sinking report that ice accumulated on the vessel at rates between 0.5 and 1 inches of ice per hour [3].

Figure 3. Photo of the vessel SANDRA FIVE on February 12, 2017, after a voyage from St. Paul Island to King Cove, AK. The vessel was operating in the same region as *Destination* during the same time [3].

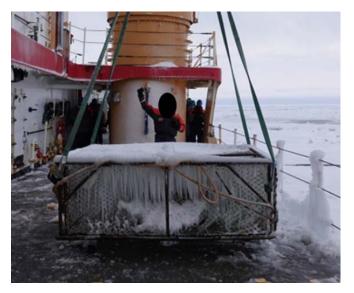
CGC POLAR STAR conducted an icing experiment while underway in the Bering Sea by continuously spraying a standard-size crab pot, 8 feet by 7 feet by 34 inches with water. Prior to the experiment, the crab pot, line and buoy were found to be 1,040 pounds. The pot was sprayed for 72 hours in temperatures which ranged between 5° F and 15° F. At the conclusion of the experiment (Figure 4), the crab pot and associated ice weighed in excess of 3,000 pounds or more than 1,960 pounds of added ice, ultimately exceeding the capacity of the load cell. Significant icing was located inside the pot [1].

By comparison, using the shoebox method on five sides of the crab pot and the rules identified in 46 CFR 28.550, a maximum of 605 pounds of ice added or 1,645 of total weight would be accounted for; a load more than three times the difference.

Figure 4. Results of freezing spray experiment by CGC Polar Star [1].

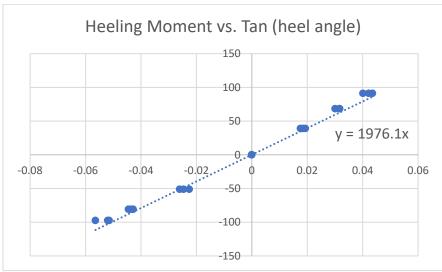
It is important to note that the Naval Architect did not provide an exhaustive list of weights to add or subtract and tank levels that were on board during the experiment, raising doubt as to its accuracy and accounting for the inconsistencies between the three lightship values shown in table 2. Also, two pendulum readings were vastly inconsistent with the others in the data set.

These values were assumed to be swapped with each other; the results of the corrected values are shown in Figure 5.

Figure 5. Plot of heeling moment vs. tangent of the heel angle (2019).

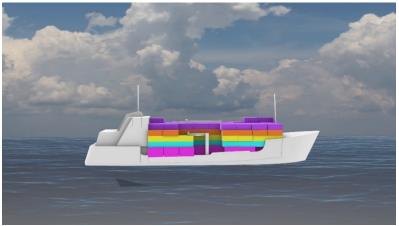
Utilizing these sources, in conjunction with the ship lines drawing, a 3D model of the vessel in the assumed departure condition was created. Figure 8 shows a rendered version of the model using Rhinoceros software.

Figure 8. 3D Model of the Scandies Rose

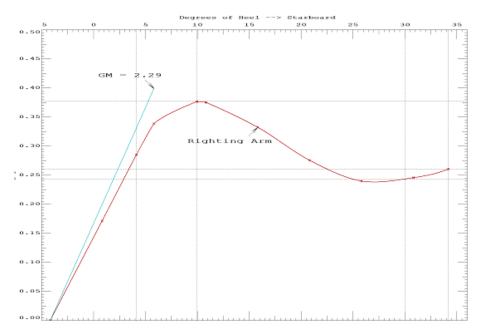
With regulatory icing applied, there is significantly less initial stability (GM) - 2.29 feet in departure as compared to 0.73 feet in the icing condition. Righting energy at downflooding was also decreased severely – 9 foot degrees versus 5.5 foot degrees. Righting energy describes the vessel's ability to absorb the effect of wind and waves before capsizing.

Figure 9. *Scandies Rose's* righting arm for the vessel's departure condition without ice. Deck immersion occurs at 10 degrees heel; downflooding occurs at 30 degrees.

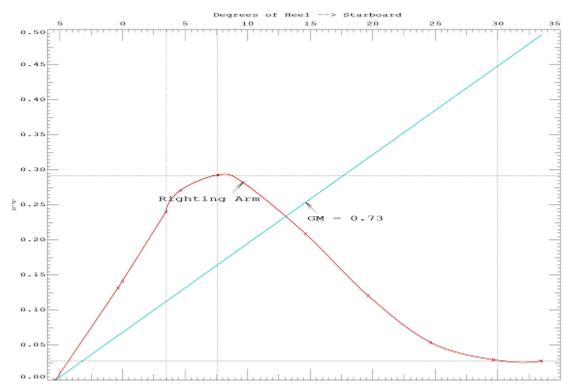
Figure 10. *Scandies Rose's* righting arm in the departure condition with worst-case icing specified in 46 CFR 28.550. Deck edge immersion occurs at 7.5 degrees heel; downflooding occurs at 30 degrees.

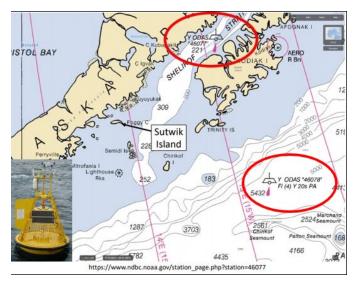
This method was applied to the *Scandies Rose* because there was sufficient weather data from NOAA buoys close to the last known position of *Scandies Rose*. The nearest weather buoys, 46077 and 46078, are highlighted in Figure 12.

Figure 12. Weather buoys closest to Scandies Rose
