Structural Evaluation of the Ontario & Western Railway's Original Iron Truss Bridge at Fish's Eddy

Brian M. Golliher, Luke H. Monaco, David F. Mazurek, U.S. Coast Guard Academy

Abstract

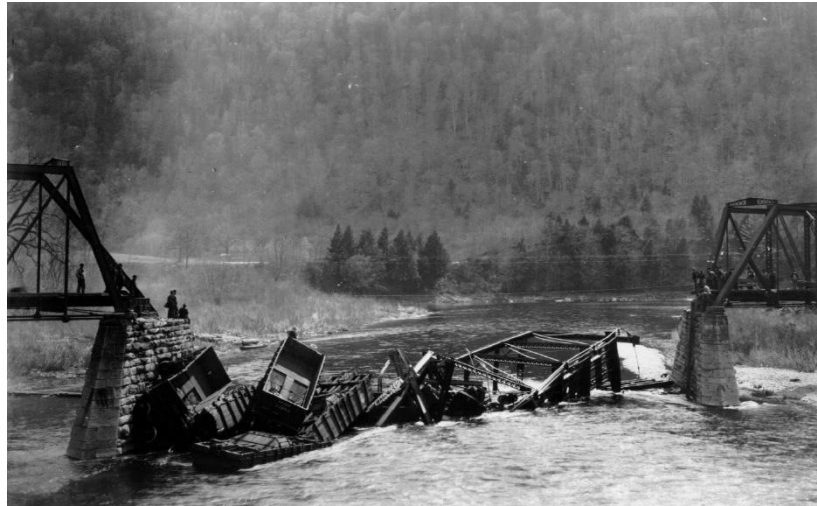
The bridge was restored and then, eleven years later, the middle span collapsed in the early morning hours of April 28, 1897, as a northbound train was crossing. Fig. 1 shows the collapsed structure. The 30-car train was under orders not to exceed 4 miles per hour while traversing the bridge, as it was to immediately take a siding to allow another train to pass. The locomotive had safely crossed the span prior to the collapse, and the train itself consisted of empty coal gondolas, eleven of which fell into the river with the failed span. Because the train was traveling so

slowly, it was felt that derailment was not a likely cause, and the bridge “was considered so perfectly safe in every particular that the officials express the greatest surprise that an accident of this kind should happen” [5].

Fig. 1. Middle span collapse of the Fish’s Eddy Bridge in 1897. (DeForest Douglas Diver Railroad Photographs #1948. Division of Rare and Manuscript Collections, Cornell University Library.).

A recent investigation by Mazurek and Tarhini [4] considered the possibility that the failure of a first-panel hanger triggered the collapse, as this could have resulted in the debris field exhibited by various photos taken after the incident, such as that shown in Fig. 1. Further, each floor beam hanger merely consisted of a single eyebar, with the floor beam riveted directly into its side. This unconventional design served to locally reduce the cross section of the eyebar, introduce large stress concentrations, and subjected the hanger to secondary bending stresses. The results of this study confirmed that the hangers were highly vulnerable and likely overstressed on a regular basis, especially during the final years leading up to the 1897 collapse.

In the study by Mazurek and Tarhini [4], the failure of a hanger was considered as a possible cause of the 1897 collapse. Such a scenario would support the resulting debris field illustrated in Fig. 1, since the failure of this component would not have necessarily led to immediate collapse, but instead might have allowed the locomotive and forward part of the train to safely exit the span while the rear portion proceeded to pile up at the site of the failed hanger. With derailed cars from the rear eventually colliding with other members of the truss, the span might have then collapsed, leaving all the cars heaped at one end as was observed.

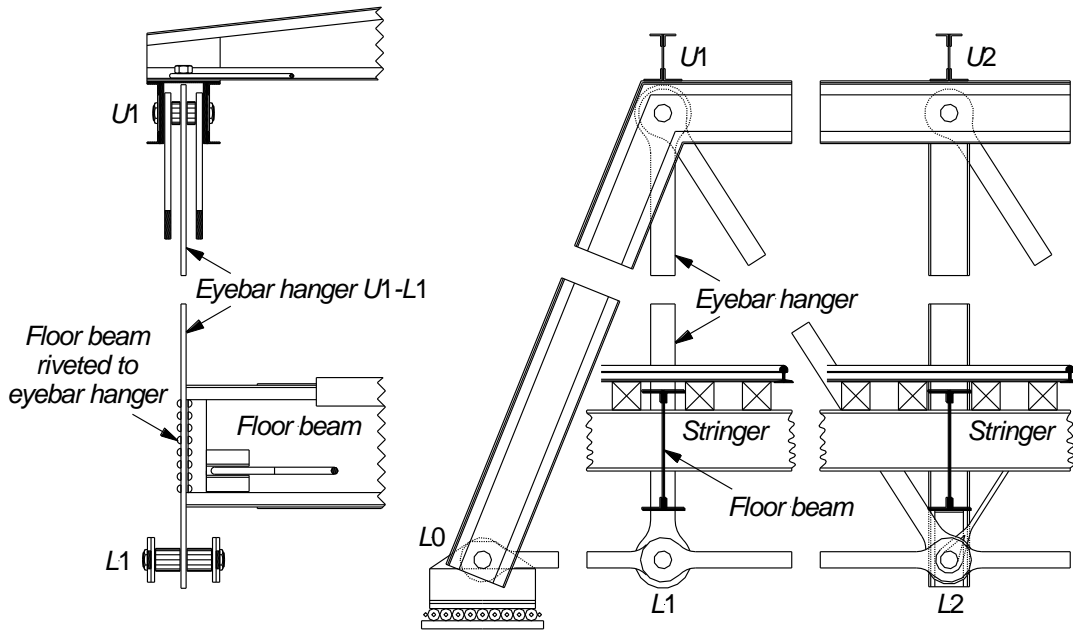
22 ft versus 10 ft). Fig. 2 highlights the main structural details. The panel points were pinned, and all other connections were riveted. With the exception of the hangers (such as member $U1-L1$), all tension members were comprised of at least two eyebars. Each hanger, on the other hand, consisted of just a single eyebar, with the supported floor beam riveted directly into the body of the eyebar. A more common practice would have been to either connect the floor beam directly to the pin joint, or to rivet the floor beam into a hanger consisting of a much more robust, built-up section.

Fig. 2. Details of the Fish's Eddy trusses, showing a partial section (left) and elevation (right).

It was previously noted that the hanger design was quite unusual as well, where each consisted of just a single eyebar, and the supported floor beam was riveted directly into the body of the eyebar. This unusual connection served to reduce the capacity of the hanger for three reasons. First was the rather significant loss of area, where the cross section through each line of rivets was almost a third less than the overall section. Second, the otherwise uniform stress field in the body of the eyebar was altered to one with very high stress concentrations. And third, there was a measure of secondary bending introduced into the eyebar by having the floor beam attached in this manner. For these reasons, it was speculated in the Mazurek and Tarhini study that the hanger might have been the most vulnerable component of the truss.
