# Students' Familiarization to Methodical Troubleshooting through a Capstone Project

Mr. Peter D. Huerter, Purdue University Northwest

In order to familiarize students with troubleshooting and identifying equipment failures, the resurrection of a relatively complex and non-functional NovaMill 3-Axis CNC Milling Machine is selected as a Capstone Senior Design project. The objectives of this project include identifying the different sub-systems of the machine, isolating each sub-system, testing and documentation of initial status, identification of failed sub-systems, repair the failed sub-system, integrate the overall machine, and perform final testing on the completed machine. A procedure will be developed to teach future students similar methodology to identify the failed components of a complex machine and finding solutions to fix it.

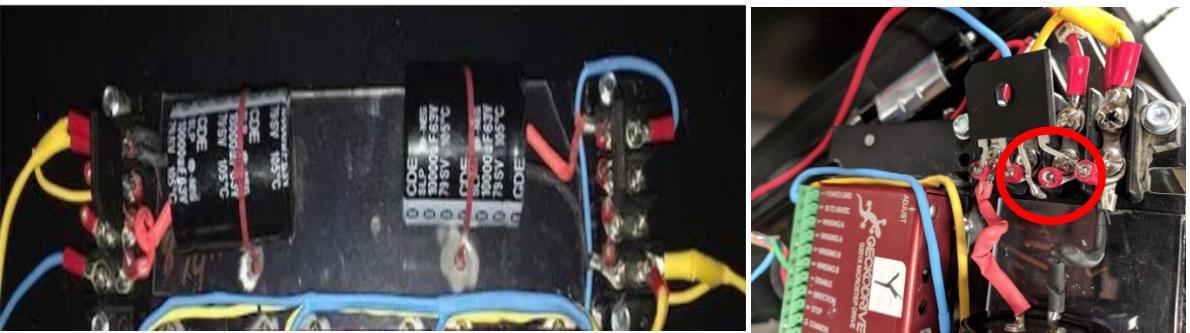
Figures 2 and 3 Dual Unregulated Power Supply and Rectifier Broken Solder Joint

Based on a conversation with the previous students who worked on the machine, a subsystemlevel hypothesis was formed that there was a problem with the Unregulated Power Supply that they had constructed (Figure 2) due to their description of a brief moment of operation before the system stopped working, and the BeagleBone Black had become unresponsive. The Unregulated Power Supply was first visually examined. The Unregulated Power Supply is split into two separate full-wave rectifiers, each constructed of one Vishay GBU8B-E3/51 Diode Bridge Rectifier to convert the AC power to DC power and one Panasonic 15000 microfarad electrolytic capacitor to minimize output ripple. The power supply converts two separate 32.5 VAC outputs from the existing control voltage transformer to two separate 40 VDC power outputs, with the negative terminals on the VDC side of the two power supplies bonded to each other. This configuration was recommended in the guide the students had followed [2] to supply DC power to the Stepper Motor Drivers and the BeagleBone Black through the Probotix Breakout Board. Visual examination of the Unregulated Power Supply resulted in the discovery of loose terminal connections on the screw terminal blocks, as well as broken solder joints (Figure 3) connecting the Bridge Rectifiers to their terminal lugs. Due to these findings, a device-level hypothesis was created that the loose terminals and broken solder joints on the Bridge Rectifier had led to unstable voltages and currents to the BeagleBone Black and Stepper Motor Drivers.

A component-level hypothesis was further generated that the Bridge Rectifiers may had been damaged from the unstable voltages and currents and may need to be replaced. The Bridge Rectifiers were isolated by removing them from the circuit entirely, and bench tested with an oscilloscope, multimeter, and 24VAC Power Supply. A separate control transformer was used to supply the bridge rectifier AC input terminals with 25.05VAC, and 33.43VDC was measured at the DC output terminals. These measurements were verified with the following calculation (25.05VAC \* 1.4 = 35.07VDC). As the measured DC voltage was roughly equivalent to the calculated DC voltage, the output voltage was determined to be within operational range. To further verify functionality, the Bridge Rectifier output waveform was analyzed with an oscilloscope, and was found to match the expected waveform for a full-wave bridge rectifier.

The above findings disproved the hypothesis that the bridge rectifiers had been damaged from unstable currents, although the decision was made to replace the bridge rectifiers anyway to safeguard against possible future failure. This choice was made due to the fact that the bridge rectifiers had been part of a system that had been faulted, were already removed from the circuit, and were relatively inexpensive to replace at only \$1.42 each.

- 1. Unregulated Power Supply
  - a. Screw terminals connecting the power supply subcomponents were found loose, potentially causing unstable voltages and currents from high-resistance connections. All screw terminals were tightened.

- b. Lugs used to connect the Rectifiers to the screw terminals were filled with solder instead of crimped, with broken solder joints found. The Rectifiers were replaced and new terminals were crimped to the new rectifier leads.

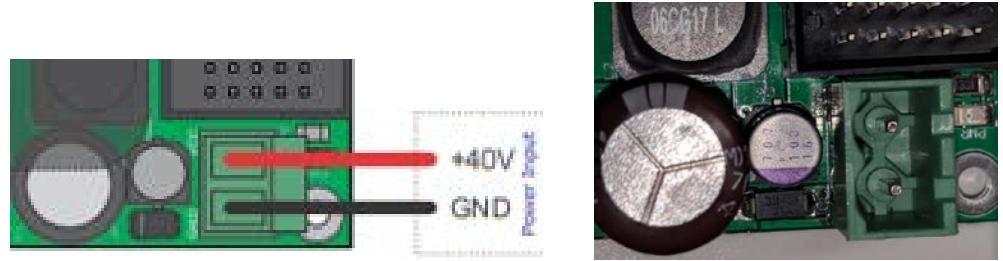
Figures 7 and 8 BPX-BB Power Terminal Wiring Diagram, GND marked as the bottom terminal

The functionality of the Probotix breakout board's MAX5090 switching voltage regulator was tested by applying 31.97VDC sourced from a benchtop power supply to the breakout board's voltage input terminals while measuring the output pins of the breakout board that supply power to the BeagleBone Black. The DC voltage was initially connected with the polarity matching the markings on the board as it was rationalized that the markings on the board were created at the time of manufacture and passed quality control checks, while the wiring diagram on the Probotix PBX-BB Wiki webpage may have been updated to reflect a new design. With the input DC voltage matching the polarity of the markings of the board, there was no measured voltage on the output pins. The polarity of the input DC voltage was changed to match the wiring diagram and

with 31.97VDC applied to the input terminals, 7.36VDC was measured on the breakout board 5 VDC output pins. According to BeagleBone.org, the maximum voltage that may be applied to the BeagleBone's power terminals is 5.2VDC [7]. If a voltage greater than 5.2VDC is applied to the power terminals, the BeagleBone will not power up. These findings further supported the hypothesis that the voltage regulator integrated in the breakout board may have been damaged by the loose connections and broken solder joints on the Unregulated Power Supply, and the increased voltage output from the breakout board regulator was preventing the BeagleBone from operating properly.

A new Probotix PBX-BB breakout board was procured and tested before installation. The second Probotix breakout board exhibited the same marking mismatch between the power terminals and the manufacturer's documentation, although a slip of paper was included in the packaging that stated this as a known issue. The board was bench tested with 31.97VDC applied to the input terminals and 5.14VDC was measured on the breakout board 5VDC output pins. A new BeagleBone was connected to the breakout board and verified to power on. Utilizing the guide provided to the previous students [3], a distribution of MachineKit was flashed to a new BeagleBone.

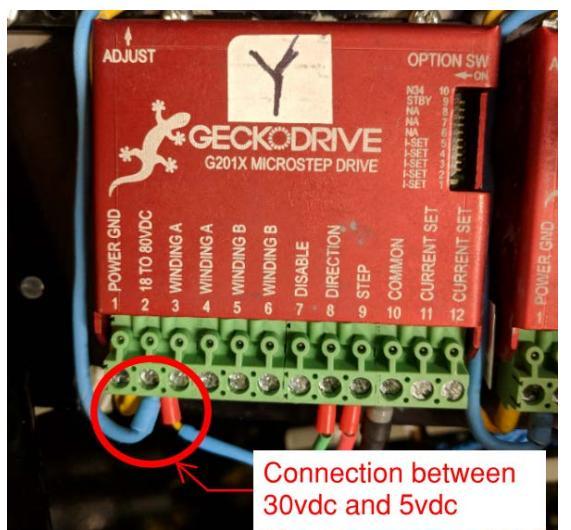
Figure 8 Unnecessary Connections on Stepper Motor Driver

Due to the fact that damage was found to the BeagleBone subsystem from its connection to the faulty unregulated power supply subsystem, a subsystem-level hypothesis was developed that the three GeckoDrive G201X stepper motor drivers installed by the previous students [1] may have been damaged as a result of unstable voltages and currents from the problems discovered with the unregulated power supply as described in section V, part 1 of this paper. Visual examination of the stepper motor driver terminal wiring produced a notable find: An unnecessary connection had been made by the previous students between each of the X, Y, and Z Driver's 18 to 80VDC power supply terminal and the Probotix breakout board's header pins, shown in Figure 8.

In the red circle shown in Figure 8 above, the wire with the blue ferrule is connected between terminal 2 on the stepper motor driver and the +40 VDC terminal of the unregulated power supply, and the wire with the red ferrule is connected between terminal 2 on the stepper motor driver and the Probotix breakout board header Pin Connector. This was noted as unusual, as there should not have been any reason for the stepper driver supply voltage to be connected to the breakout board. A decision was made to study the Probotix breakout board in greater detail to discover what effect if any this connection had made on the circuitry and components of the breakout board and BeagleBone Black. Closer examination of the Probotix breakout board found a completely burnt-out trace in the board shown in Figure 9. The burnt trace was continuity-tested to all of the Breakout Board's pins and was found to correspond to the 5VDC rail that is bussed to its breakout header pins and connects to the BeagleBone power supply pins. Electrically, a connection had been made as shown with the red line in Figure 10.

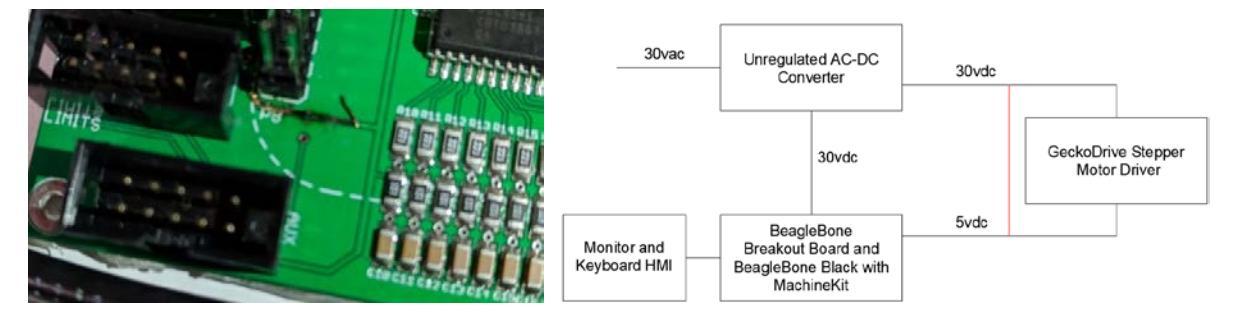
Figures 9 and 10 BPX-BB Burnt-Out Trace and Effective Electrical Connection due to miswiring on Stepper Motor Driver

This connection on the driver's power supply terminal would result in the full 40VDC supplied to the stepper drivers completely bypassing the breakout board's MAX5090 voltage regulator and applying 40VDC to the 5VDC power supply pins to the BeagleBone Black. This finding was determined to be the primary contributing factor in the problems discovered with the BeagleBone Black and Probotix breakout board discussed in section V, part 3 of this paper.

- b. The existing Probotix Breakout Board was damaged by a wiring error found on the power terminals of the Stepper Motor Drivers. A new Probotix Breakout Board was purchased to replace the damaged board.

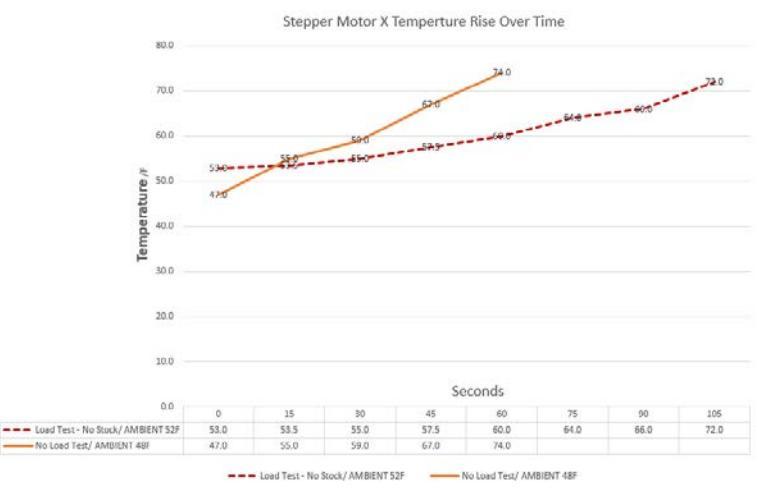
Figure 11 X-Axis Stepper Motor Test Results

X-Axis stepper Motor observations included a random intermittent grinding sound that occurred under both no-load and load conditions, along with increased motor noise while operating. Temperature rise on the stepper motor increased sharply when the grinding sound began to 19 degrees Fahrenheit over 105 seconds. The X-Axis stepper motor was able to drive the X-Axis of the CNC machine.

The above findings proved that due to the large temperature rise found on the X and Y Axis Stepper Motors, the motors are likely due to fail soon. The Z-Axis stepper motor appears to be in proper operating condition.

- 4. Stepper Motors (X, Y, Z Axes)
  - a. The X and Y-Axis Stepper Motors should be replaced due to their loud operation, grinding sounds, and high temperature rise over the 105 second function test. Additionally, the existing Stepper Motors are no longer manufactured or supported by the manufacturer. Recommended replacement X and Y Stepper Motors are detailed in Appendix C at the end of this report. Furthermore, although the Z-Axis Stepper Motor passed the function test it is also no longer manufactured or supported by the manufacturer. If desired, an additional Stepper Motor of the same make and model as recommended for the X and Y-Axes can be used to replace the Z-Axis Stepper, although an adapter plate.

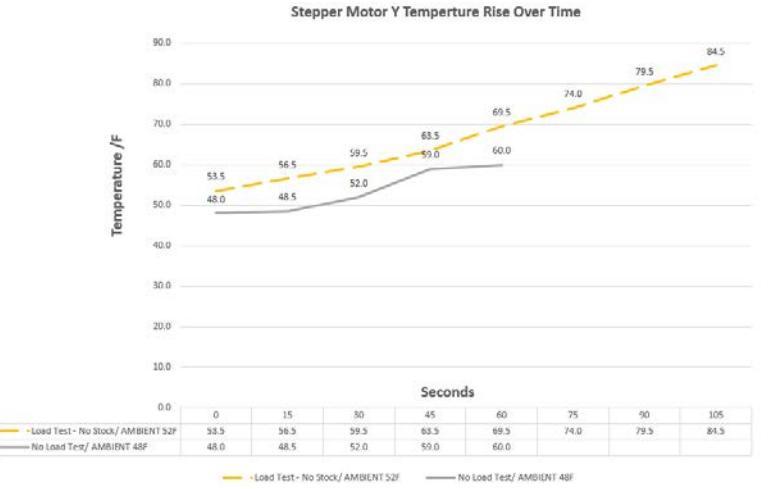
Figure 12 Y-Axis Stepper Motor Test Results

Y-Axis stepper motor observations included increased motor noise while operating. Temperature rise on the stepper motor was 31 degrees Fahrenheit over 105 seconds, although the Y-Axis stepper motor did not exhibit a grinding sound like the X-Axis stepper motor. The Y-Axis stepper motor was able to drive the Y-Axis of the CNC machine.

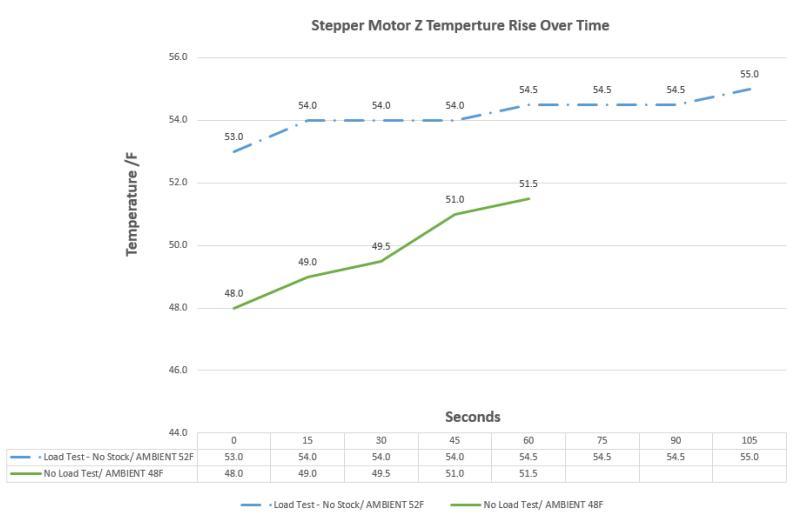
Figure 13 Z-Axis Stepper Motor Test Results

Z-Axis stepper motor observations included very quiet motor noise while operating. Temperature rise on the stepper motor was 2 degrees Fahrenheit over 105 seconds, and the Z-Axis stepper motor did not exhibit a grinding sound like the X-Axis stepper motor. The Z-Axis stepper motor was able to drive the Z-Axis of the CNC machine.

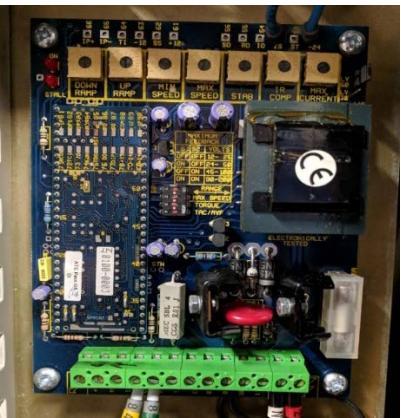
Figure 14: Spindle Motor Control Board

As most of the control wiring to the Spindle Motor Control Board detailed in Figure 14 had been removed and not replaced by the previous students, and based on previous findings throughout this project while troubleshooting the power supply and stepper motors, a subsystem-level hypothesis was developed that the spindle motor and spindle motor control board may have been damaged by previous attempts to gain control of the spindle motor.

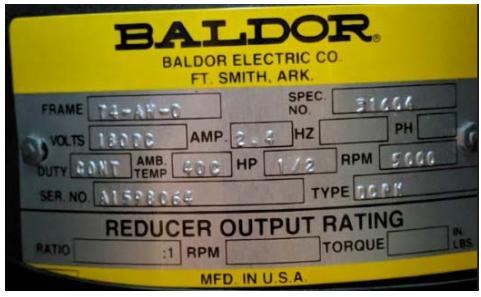
Figure 17 Spindle Motor Nameplate

A continuity test was performed between the spindle motor positive and negative power leads, and 5.5 ohms of resistance was measured. The nameplate value from Figure 17 for rated voltage (180VDC) and the measured resistance (5.5 $\Omega$ ) were used to calculate the stall current  $I_{STALL}$ = 32.73A. The calculated stall current (32.73A) and the nameplate current (2.4A) were used with the measured resistance (5.5 $\Omega$ ) to calculate the Back EMF Voltage as follows:

Finding no problem with the measured resistance value of the motor, the Spindle Motor was determined to be safe to connect to the Sprint 400 Spindle Drive.
