## **2006-2643: FIVE MILES IN FORTY-FIVE DAYS - REBUILDING THE I-10 TWIN SPANS**

**John Ryan, SE/ES, LLC**

## **5 miles in 45 Days – Rebuilding the I-10 Twin Spans**

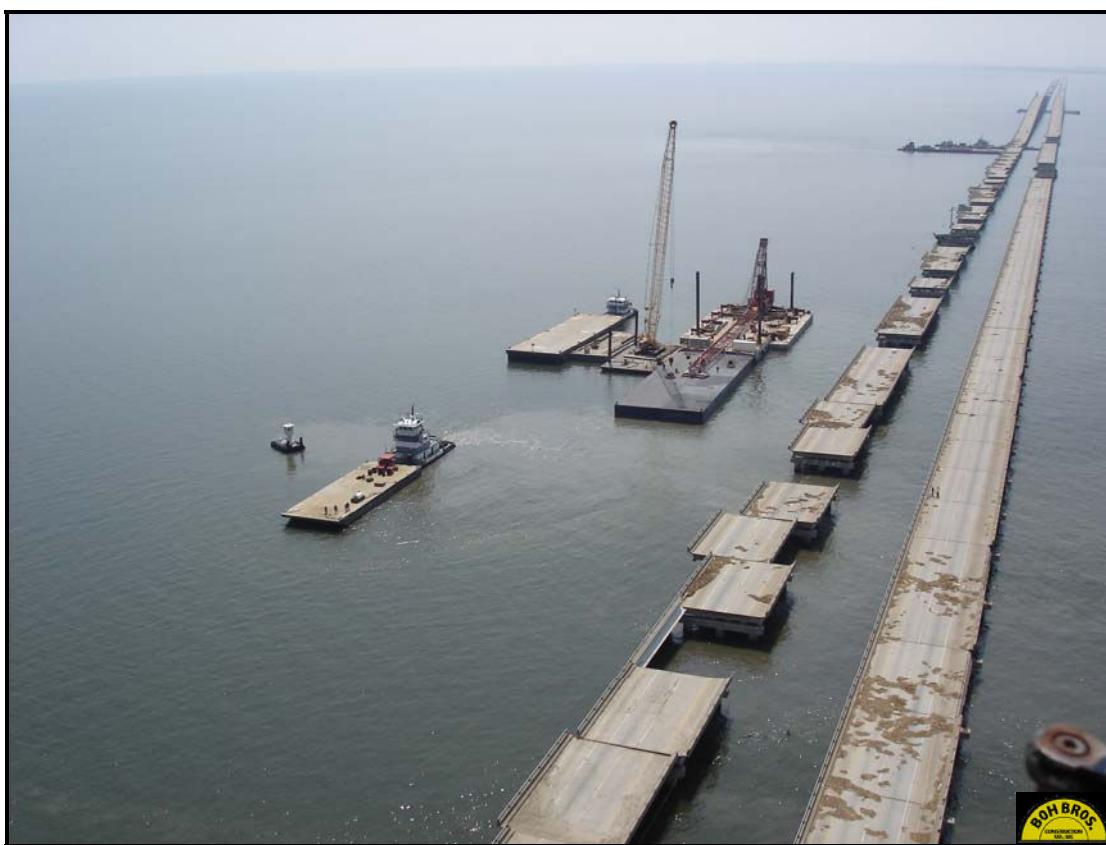
by large surf from eastern Louisiana to western Florida, and a coastal storm surge, later measured over 15.5 ft near Pass Christian, Mississippi, was fast approaching. As Katrina made land fall near Barataria Bay, Louisiana, it weakened to a category three hurricane, with maximum sustained winds of 125 mph. With storm surge gathering just to the north of the mouth of the Mississippi River, and category three easterly winds driving the massive volume of water into Lake Pontchartrain through the Mississippi Sound and Lake Bourne, wind-speed would quickly become a secondary concern for south-east Louisiana. Lake Pontchartrain filled with water from the Gulf of Mexico that would eventually be thrust through the south-shore levies and into sub-sea level areas of New Orleans East. The massive influx of water into Lake Pontchartrain caused the water level to rise as high as 15-20 feet above normal lake levels. The sudden rise in the lake was particularly devastating to the double-span US Interstate 10 Bridge (Twin Spans), which crosses Lake Pontchartrain at its narrowest point. As a result, nearly 40% of the simple-span, pre-cast girder and deck segments of the east-bound and west-bound bridges were damaged. The damage to the bridge decks ranged from shifting to complete removal of spans (Figure 1). The local area was devastated, evacuated, and temporarily non-functional (Figures 2 and 3).

**Figure 1:** I-10 Bridge Damage

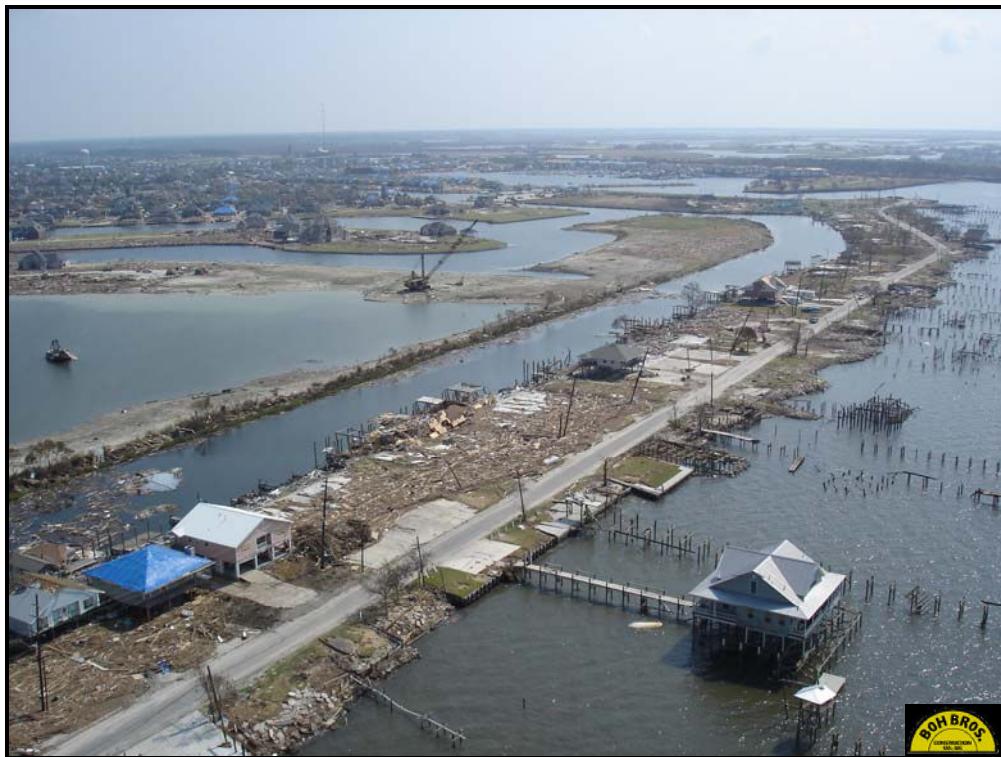
**Figure 2:** Infrastructure Damage – North Shore of Lake Pontchartrain

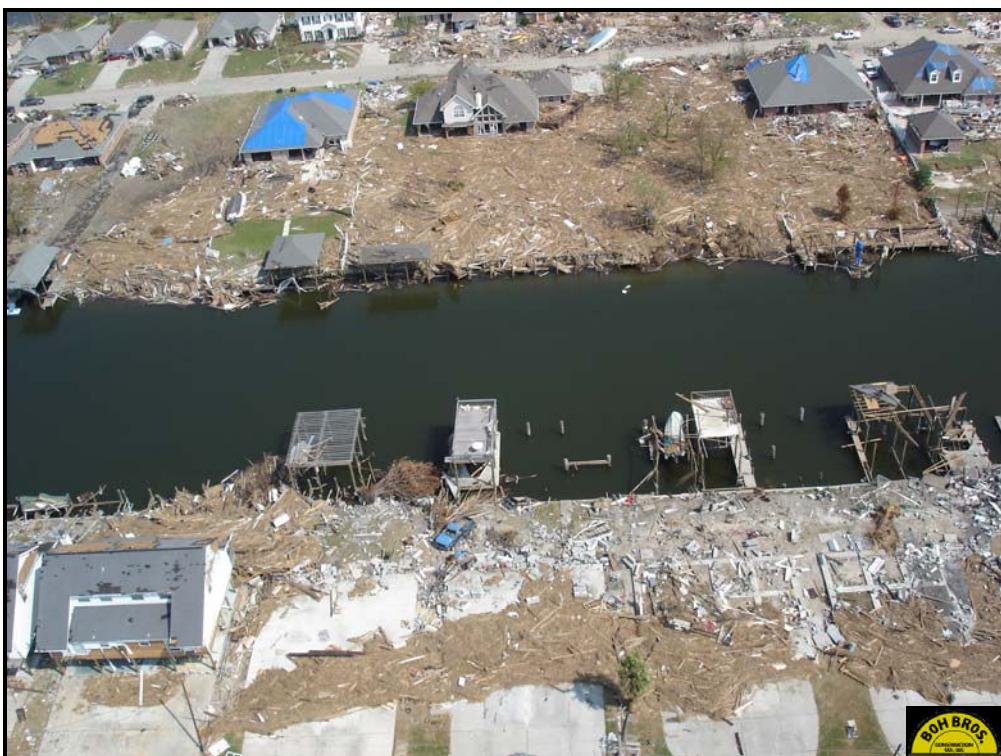
**Figure 3:** Infrastructure Damage – North Shore of Lake Pontchartrain

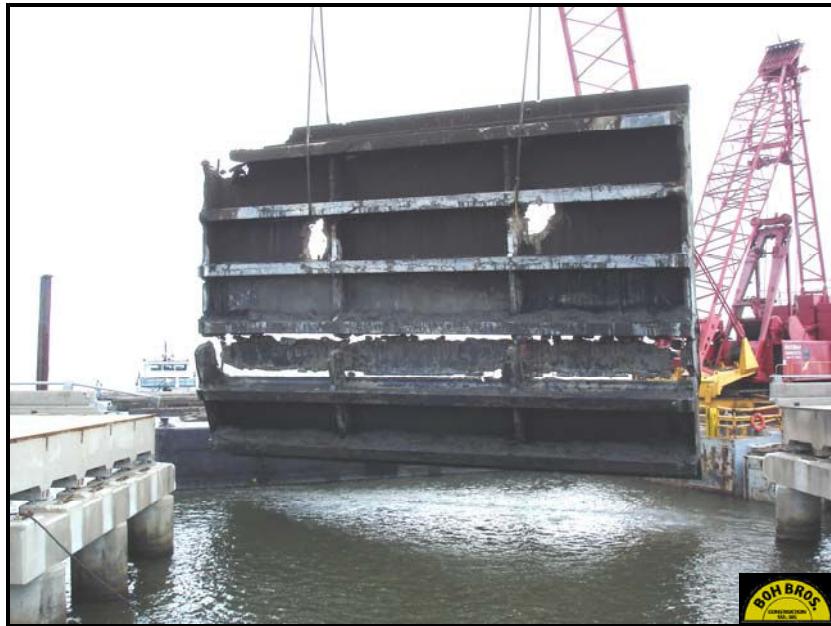
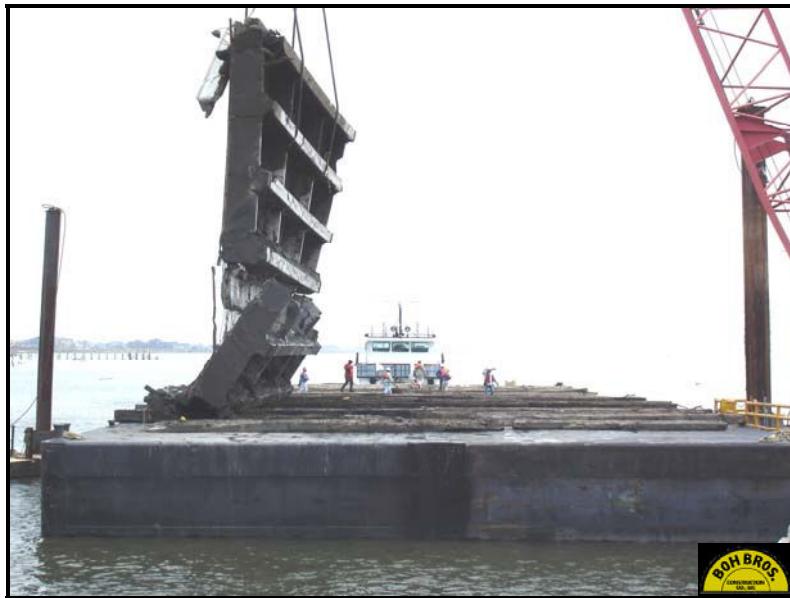
During the storm 39 deck sections were completely removed from the east-bound bridge and deposited in the lake adjacent to the bridge. The lake level near the bridge is between 8 and 12 feet, with a deeper channel dredged through a single high clearance bridge section located approximately one mile from the north approach. The barges used to support cranes, pile drivers, and trailers drafted between 4 ft and 8 ft of water, and tugs driving the barges drafted approximately 9 ft of water. To position the construction barges properly, submerged decks had to be located and removed prior to commencing repair operations. The removal operation was labor intensive both in and out of the water. Divers were used to locate bridge sections. Once a bridge section was located, holes in the deck (pick-points) were punched to allow for passage of slings and rigging, using an excavator-mounted hydraulic ram. Because the decks were heavily damaged, the location of the pick-points needed to be carefully selected to ensure a stable lift. Audio communication with divers was the only means of locating the position of the divers in the water. The inability to visually locate the divers in 8 to 12 feet of water from the surface created a hazard to the divers as they guided the hydraulic ram. Being pinned by barges drafting all but two feet of available water depth or seriously injured by the hydraulic hammer in the murky water were two primary hazards. After successfully rigging a deck, the work was only halfway complete. Lifting the 285-ton deck sections required the use of a Manitowoc 4600 crane with ringer attachment and a 200-ft. boom. Heavy marine lifting in the best conditions requires careful evaluation and risk management of wave action and wind conditions. In this case, the stability of the load presented a significant additional risk. Loss of deck material during the lift caused instantaneous load shifts and rupture of material being bent and then put into direct tension as the sections were being lifted (Figures 4 and 5). The result was shock loading to the crane. After removing approximately 60% of the submerged deck sections, permission to break up the remaining submerged deck sections and drive the rubble into the lake bottom was granted by the State of Louisiana. Although the objective to seeking this allowance was based primarily on safety, it resulted in a much more efficient method

**Figure 4:** Submerged Deck Removal

**Figure 5:** Submerged Deck Removal

of clearing debris adjacent to the bridge. Since debris removal was a critical path item, the early completion of Phase I can be attributed, in part, to the alternative method used.

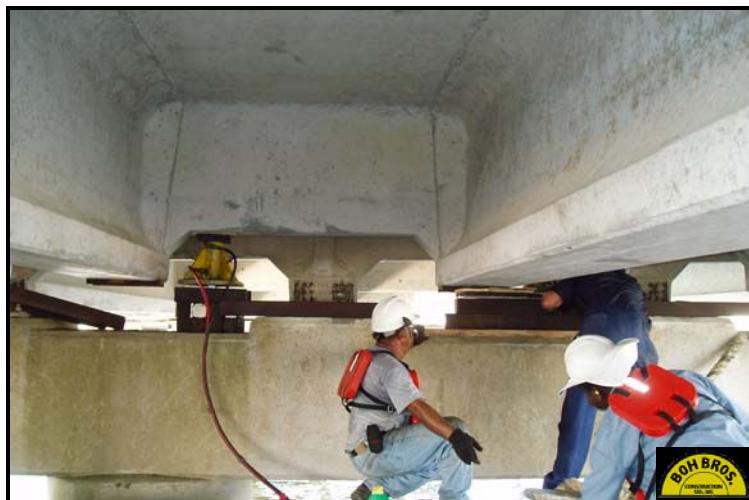
**Figure 6:** Vertical Jacking of Deck on to Teflon Slide Plates

to the east-bound span began. The first method of re-aligning deck sections consisted of jacking a deck vertically onto Teflon slide plates between pile caps and girders, and jacking the decks horizontally back to their original bearing pad locations (Figure 6). Horizontal jacking was accomplished by positioning hydraulic pipe jacks at an angle between the curb of properly aligned deck segments and the curb of deck segments to be moved (Figure 7). Positioning the slide plates required the use of a barge beneath the bridge. However, horizontal jacking was done on the top side of the bridge and did not require the use of a barge during jacking operations. A relatively light demand for barge support and independence from wave action resulted in a very efficient method of re-alignment and was utilized for deck sections requiring re-alignment of five feet or less.

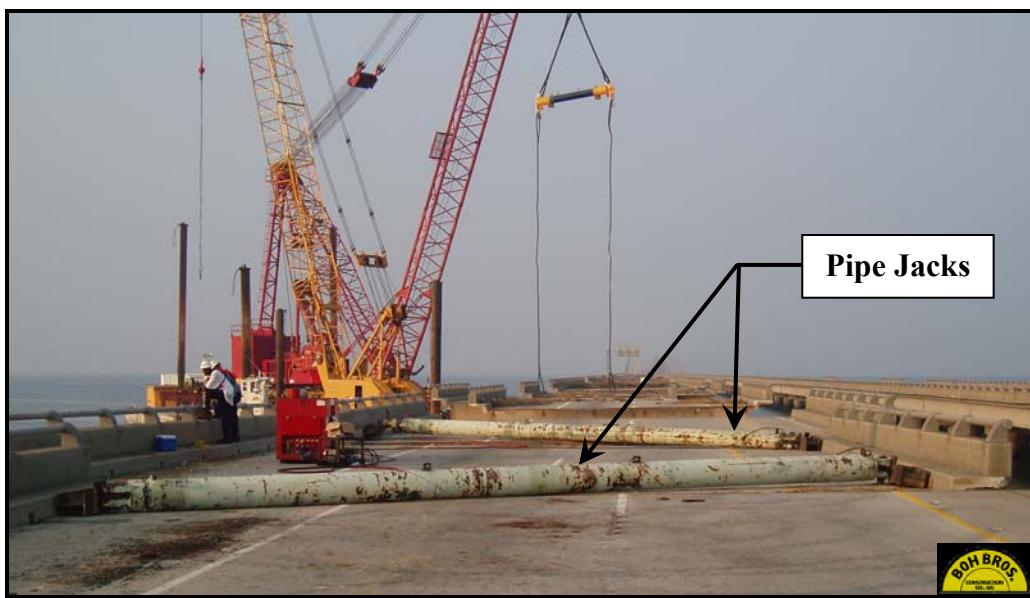
**Figure 7:** Horizontal Re-alignment Jacking

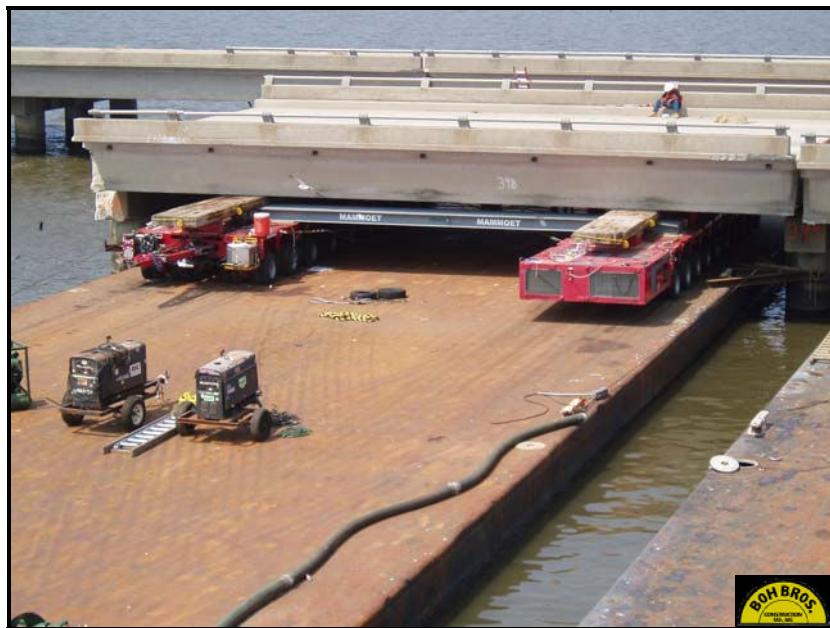
**Figure 8:** Tri-directionally Adjustable Barge Mounted Trailers

For deck sections which were out of alignment by more than five feet, barges were used for support. An innovative trailer system on top of the barges was also utilized, which greatly increased efficiency. Similar bridge repair operations in the past consisted of providing a fixed support for a deck section on a barge deck. Moving and placing the deck segment precisely onto the bearings could then be accomplished by adjusting the location of barge. This process requires constant adjustment for lateral movements of the barge due to current, as well as vertical wave action, and is extremely time-intensive. To save time, a new concept was conceived by Boh planners. The apparatus for the concept consisted of a tri-directionally adjustable, barge-mounted trailer system (Figure 8). With the deck section jacked high enough to clear the bearings, a barge was moved to a suitable location in the bent where re-alignment was required, and then anchored to bridge piles, fixing its location laterally. The steer-able trailer system was then used to move the deck section into proper alignment. The degree of difficulty related to making fine adjustments within a tolerance of  $\pm \frac{3}{4}$  in. with a tug driven barge was thereby eliminated. The same method was used for the transfer of deck segments, cannibalized from the west-bound bridge. The innovative trailer system was cited by Boh planners as being the primary reason for completing the 45 day project with 16 days left on the schedule.

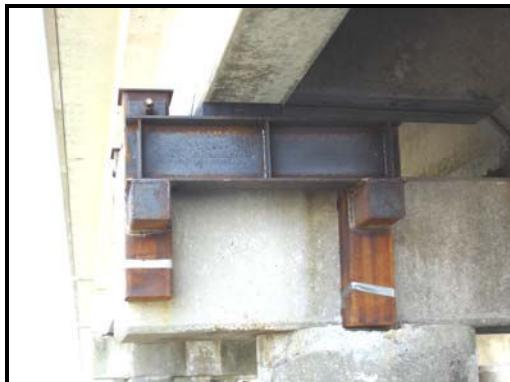
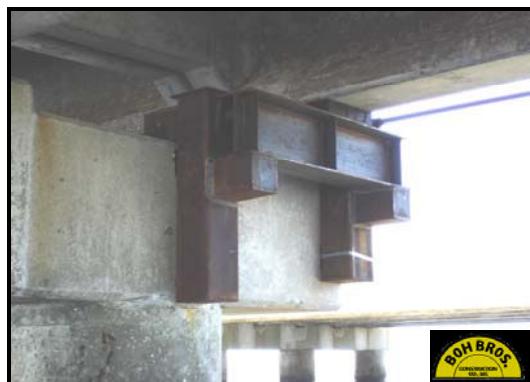
Throughout the repair projects, conditions of deck sections and pile groups were evaluated to determine future load carrying capabilities. Damage to girder ends and pile caps, resulting from anchorage breaks at bearing pads, was the most common cause of unserviceable girder and support conditions. In most cases damage was primarily

**Figure 9:** Cap Saddle

**Figure 10:** Cap Saddle

confined to within 18 in. of the girder end, while the remainder of the deck and girder section remained undamaged. To create a reliable load path for the transfer of the reaction at the end of a girder to the pile cap, steel saddles were installed (Figure 9 and 10). The cap saddles provided a clear load path where the reliability of the girder or pile cap material was uncertain and prevented the need for complete replacement of many deck segments.

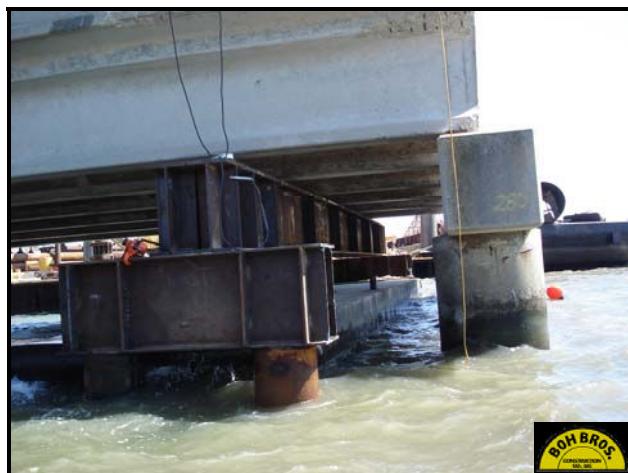
**Figure 11:** Auxiliary Steel Bent

In addition, several piles were damaged from the impact of decks sliding into the lake. Since it was difficult to evaluate the extent of damage to these piles, steel bents were installed to add reliability to damaged pile groups. The new bents were constructed by adding one steel support to on each side of the damaged pile group (Figure 11). The supports consisted of two round hollow steel piles on each side of the bridge span. A short transfer member was installed between piles, which supported a double steel girder passing beneath the bridge and supporting the girders. These bents were able to be constructed without removing existing pile groups or deck segments, resulting in significant time savings (Figure 12).

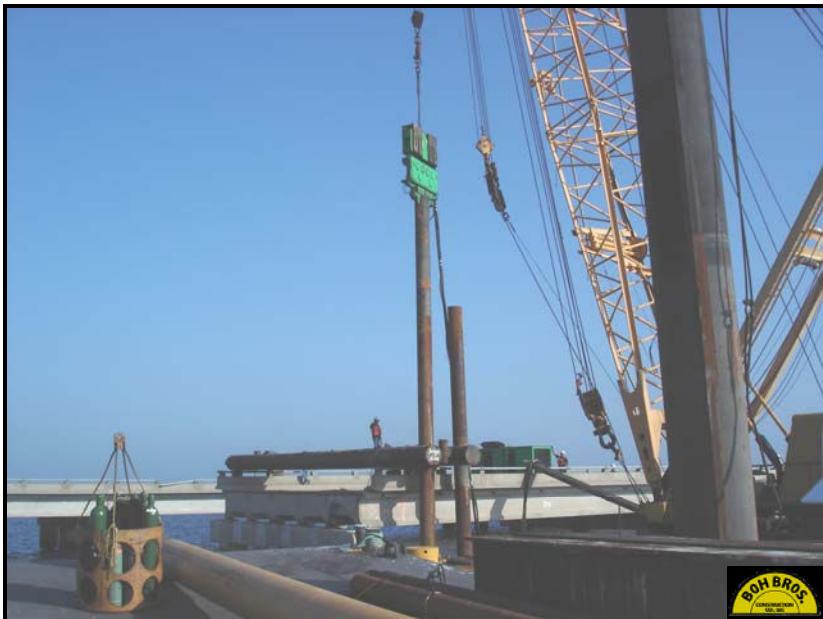
**Figure 12:** Pile Installation for Auxiliary Steel Bents
