2018 ASEE Mid-Atlantic Section Spring Conference: Washington, District of Columbia Apr 6

Seismic Vulnerability Assessment of a Non-Ductile Reinforced Concrete Shear Wall Building

This paper presents results of a capstone senior project at California State Polytechnic University, Pomona. Students conducted a vulnerability assessment of a five-story building constructed in Southern California. The structure has non-ductile concrete shear walls at the core and gravity frames at the perimeter. Partial infilled walls exist within the perimeter frames, creating captive columns. Students studied as-built plans for the structure and conducted an assessment of the building based on FEMA-310. They modeled the structure in ETABS and performed an analysis under combined gravity and lateral loads. The students identified the most vulnerable structural elements in the building. They proposed a retrofit scheme to mitigate the risk of collapse due to seismic loading, which includes adding supplemental reinforced concrete shear walls to reduce torsion, shotcreting to increase wall shear capacities, saw-cutting infill walls, and fiber wrapping to increase the shear capacity of vulnerable perimeter

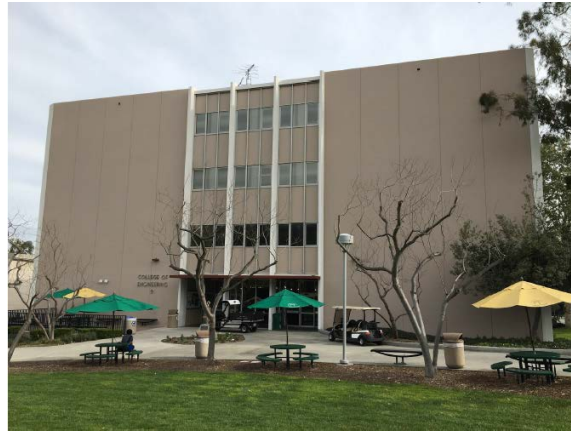
on the north side is on the second floor level (see Figure 1). The elevator core is located at the south entrance and houses three elevators. At the south end, the second floor slab creates a breezeway at the ground level between this five-story building and an adjacent two-story building. The height of the first story, which is partially underground, is 12.5 ft., while the height of each of the upper four stories is 13.5 ft. Thus, the total height of the building from the ground level to the main roof is 66.5 ft. In addition, a two-story penthouse with dimensions of approximately 27 ft. by 70 ft. and 26 ft. tall is located above the main roof. The penthouse, which is fabricated of structural steel wide-flange sections and a corrugated metal deck roof, contains an electric supply area, a cooling tower, a fan room and an elevator machine room.

Figure 1: North elevation of five-story building

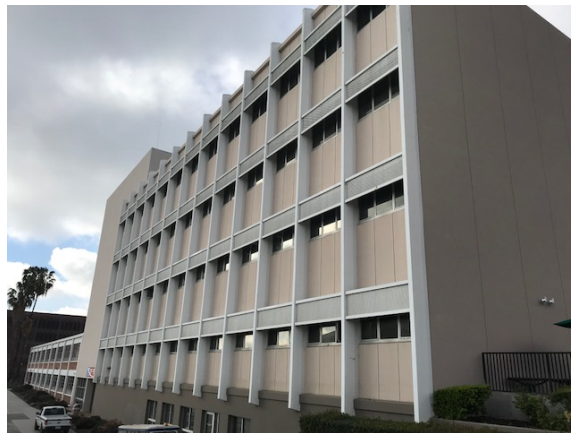
At the east and west elevations, between the perimeter gravity frames, partial infill walls rise three-quarters of the story height to accommodate continuous rows of windows in stories 2 through 5 (See Figure 2). The infill walls reduce the effective height of each column in these stories, resulting in a condition referred to as a captive column. This effect has been seen to promote an undesirable shear-dominated failure in the columns³⁻⁶. This is attributed to the increased column lateral stiffness, which results in the attraction of higher shear loads. As Guevara and Garcia³ point out, any captive column designed and built prior to the mid 1970's may be vulnerable in shear, due to the fact that captive column considerations did not appear in the governing design codes until the 1973 Uniform Building Code⁷. Because this building was constructed in 1965, it is concluded that captive column effects will need to be mitigated.

Figure 2: East elevation of five-story building

Lastly, a significant effect that requires mitigation is the captive column condition which occurs primarily along the east and west faces of the structure. The ETABS model showed that the majority of the captive columns are overstressed, but the most severe columns are located in the north-east and north-west corners of the building. A mitigation strategy involves saw-cutting the infill walls to create a separation between the infill walls and the columns. Furthermore, the columns can be strengthened using fiber wrap.

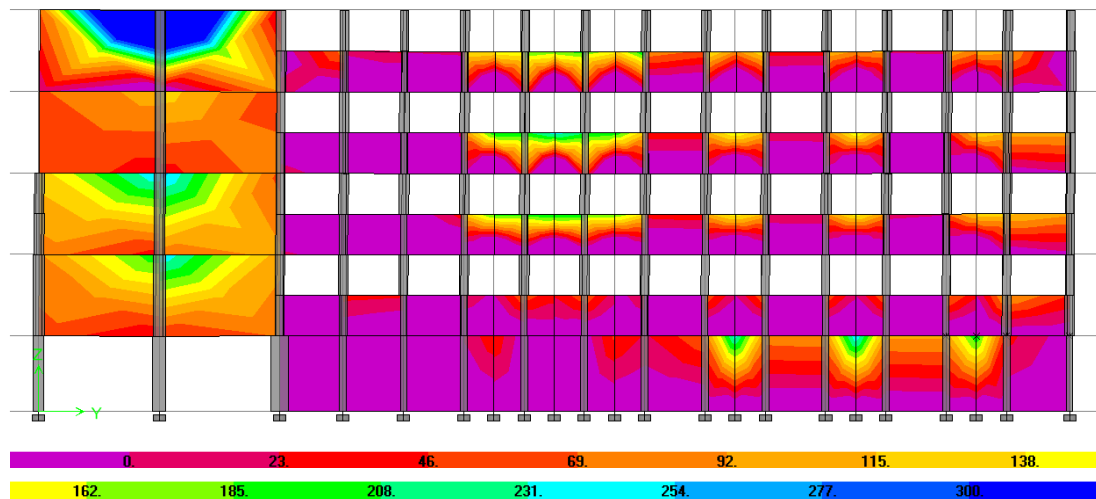
It was found that several concrete shear walls in the building exceed allowable stress limits under seismic loads. FEMA-310⁸ limits the shear stress to less than 100 psi or $2\sqrt{f'_c}$. For a concrete strength of 4,000 psi, the second term yields 126.5 psi. Thus, the 100 psi limit controls. Figure 4 shows contours of maximum stress in the east walls under combined gravity- and earthquake loading. It is clear that stresses in several walls exceed the allowable limit. A mitigation strategy would consist of reducing the eccentricity (i.e., the distance between the center of mass and the center of rigidity of the building) and increasing the shear strength of the walls by using shotcrete to thicken them or by utilizing fiber wrap.

Figure 4: Stress contours of shear walls along east elevation, obtained from ETABS (psi)
