# Students' Familiarization to Methodical Troubleshooting through a Capstone Project

Mr. Peter D. Huerter, Purdue University Northwest

In order to familiarize students with troubleshooting and identifying equipment failures, the resurrection of a relatively complex and non-functional NovaMill 3-Axis CNC Milling Machine is selected as a Capstone Senior Design project. The objectives of this project include identifying the different sub-systems of the machine, isolating each sub-system, testing and documentation of initial status, identification of failed sub-systems, repair the failed sub-system, integrate the overall machine, and perform final testing on the completed machine. A procedure will be developed to teach future students similar methodology to identify the failed components of a complex machine and finding solutions to fix it.

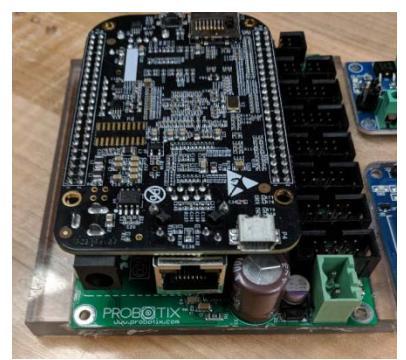
Figures 4 and 5 BeagleBone Black Connected to Probotix BBX-BB Breakout Board and Attempt to Connect to Existing BeagleBone via PuTTY

Recalling the fact that the previous students had listed the BeagleBone Black as unresponsive, a subsystem-level hypothesis was developed that due to the discovered problems with the unregulated power supply the BeagleBone may have been damaged. The BeagleBone was isolated completely from the control circuitry and disconnected from the Probotix breakout board. The connection between the BeagleBone Black and the Probotix breakout board is detailed in Figure 4. A connection was made between the USB port on the BeagleBone and a USB port on a PC. PuTTY, an open-source terminal emulator, was launched on the PC to attempt to establish an SSH (The SSH protocol, also referred to as Secure Shell, is a method for secure remote login from one computer to another). connection to the BeagleBone. The Beaglebone connected to the PC and displayed the boot screen in the PuTTY terminal (Figure 5) but was completely unresponsive to entry of the default MachineKit password: "machinekit".

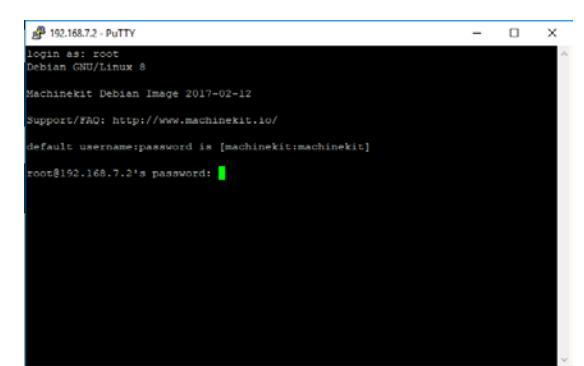
Using PuTTY established that the BeagleBone could handle an SSH connection but was unresponsive to input. WinSCP, software commonly used for file transfer between a local and remote computer, was used to establish an SSH connection to the BeagleBone. The Beagle Bone's directory system was explored and found to be empty of data. These findings supported the hypothesis that power supply instability may have corrupted the BeagleBone. The connection between the unregulated power supply's 40VDC output and the BeagleBone Black's 5VDC input is made through a Probotix PBX-BB breakout board. A device-level hypothesis was formed that the voltage regulator integrated in the breakout board may have been damaged by the loose connections and broken solder joints on the unregulated power supply. According to the Probotix PBX-BB Wiki page, the breakout board utilizes a MAX5090 based 5V /2A switching regulator (Figure 6) that accepts voltages up to 76VDC, and the 5V rail is bused out to the breakout header pins [6].

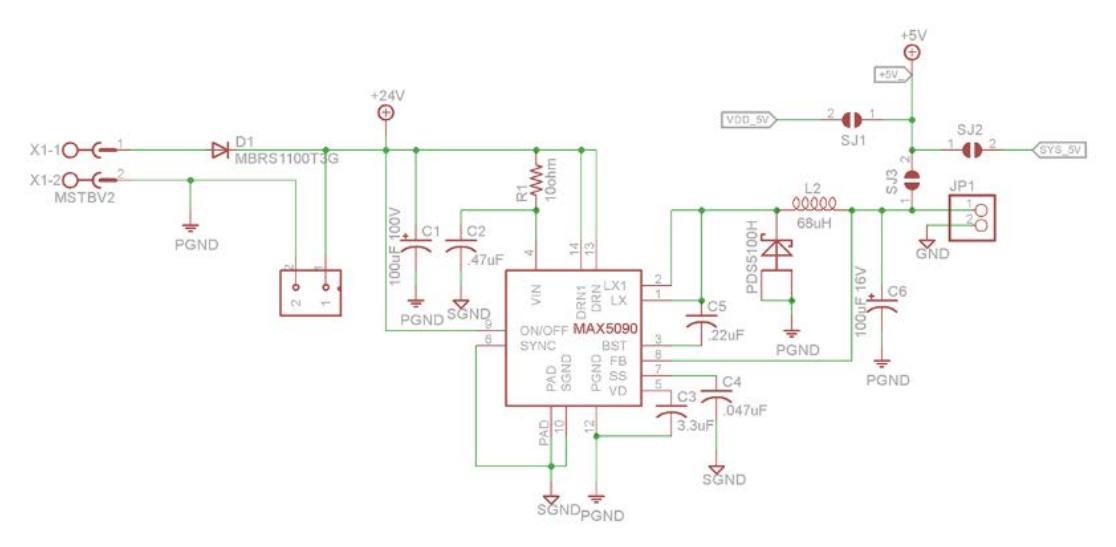
Figure 6 BPX-BB Breakout Board Voltage Regulation Circuit

As most of the voltage regulation circuit shown above in Figure 6 was integrated into the PCB layers, direct examination of the circuit was impractical. Visual examination of the voltage input terminals of the Probotix breakout board found that there was a mismatch between the markings of the VCC and GND terminals on the board and the order specified on the manufacturer's wiring diagrams. A component-level hypothesis was developed that the previous students may have incorrectly followed either the manufacturer's documentation or the board terminal markings when connecting power to the board, potentially damaging the breakout board's MAX5090 voltage regulator. Due to examination of the circuit shown above in Figure V.2.3 this hypothesis was ruled unlikely, but possible and thus worth pursuing. Due to the construction of the Breakout Board, it was difficult to determine if the markings on the board or the manufacturer's wiring diagrams were correct, shown in Figures 7 and 8.

with 31.97VDC applied to the input terminals, 7.36VDC was measured on the breakout board 5 VDC output pins. According to BeagleBone.org, the maximum voltage that may be applied to the BeagleBone's power terminals is 5.2VDC [7]. If a voltage greater than 5.2VDC is applied to the power terminals, the BeagleBone will not power up. These findings further supported the hypothesis that the voltage regulator integrated in the breakout board may have been damaged by the loose connections and broken solder joints on the Unregulated Power Supply, and the increased voltage output from the breakout board regulator was preventing the BeagleBone from operating properly.

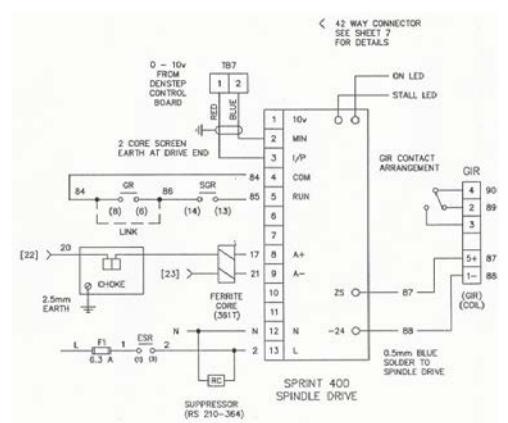
Figure 15: Spindle Motor Control Board Wiring

As most of the control wiring to the Spindle Motor Control Board detailed in Figure 14 had been removed and not replaced by the previous students, and based on previous findings throughout this project while troubleshooting the power supply and stepper motors, a subsystem-level hypothesis was developed that the spindle motor and spindle motor control board may have been damaged by previous attempts to gain control of the spindle motor.

To verify the function of the spindle motor control board the manufacturer's drawing detailed in Figure 15 was analyzed, and a manual for the Sprint 400 Spindle Drive. A wiring diagram for basic control connections was found in the Sprint 400 Spindle Drive Manual (Figure 16 below) that demonstrated that the board could be controlled with an analog input supplied from a 10k  $\Omega$  potentiometer for speed control and a digital input from a normally open momentary pushbutton as a run signal. Additionally, by moving a jumper on the Spindle Drive, the board could be powered with the more common 120 VAC instead of 240 VAC.

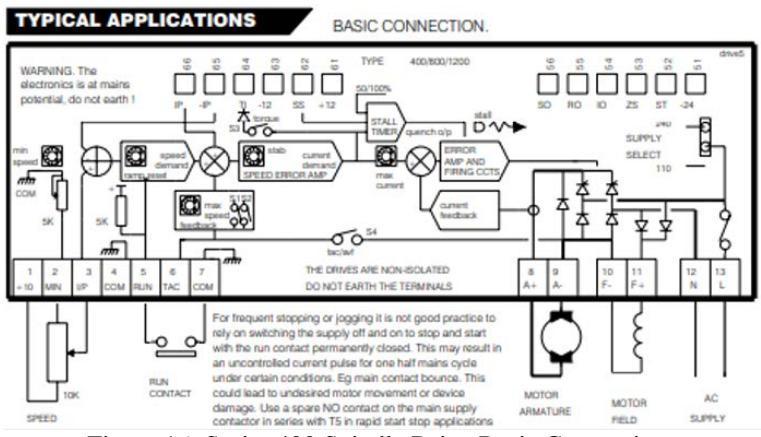
Figure 16: Sprint 400 Spindle Drive Basic Connections

The Sprint 400 Spindle Drive was completely removed from the control panel and control panel wiring and bench tested. A digital multimeter was connected to terminals 8 and 9 of the spindle drive to measure output DC voltage to the spindle motor, a 10k  $\Omega$  potentiometer was connected to terminals 1, 2, and 3 for speed control, and a normally open momentary pushbutton was connected to terminals 5 and 7 as a run signal. Last, the jumper on the board was moved from the 240 VAC position to the 120 VAC position, and 120 VAC was connected to terminals 12 and 13 to supply power to the spindle drive. The 120 VAC power was energized, and voltage was measured across terminals 8 and 9 while the momentary pushbutton was pressed. Finding an initial value of 100 VDC at terminals 8 and 9, the potentiometer was adjusted while the momentary pushbutton was held closed. The output voltage on terminals 8 and 9 with no load was observed to vary between 0 VDC to 165 VDC. Based on the Spindle Drive test findings, the spindle drive was determined to function properly. As the spindle motor functionality had not yet been tested, the Spindle Drive was reinstalled in the Control Panel but not connected to the spindle motor. To better understand the spindle motor design, the CNC machine was dismantled until the nameplate of the spindle motor and wiring diagram are shown in figures 17 and 18 respectively.

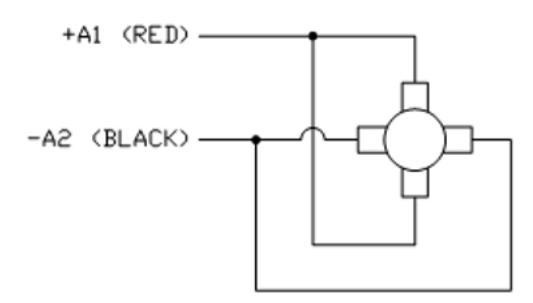
Figure 18 Spindle Motor Wiring Diagram

A continuity test was performed between the spindle motor positive and negative power leads, and 5.5 ohms of resistance was measured. The nameplate value from Figure 17 for rated voltage (180VDC) and the measured resistance (5.5 $\Omega$ ) were used to calculate the stall current  $I_{STALL}$ = 32.73A. The calculated stall current (32.73A) and the nameplate current (2.4A) were used with the measured resistance (5.5 $\Omega$ ) to calculate the Back EMF Voltage as follows:
