Structural Evaluation of the Ontario & Western Railway's Original Iron Truss Bridge at Fish's Eddy

Brian M. Golliher, Luke H. Monaco, David F. Mazurek, U.S. Coast Guard Academy

Abstract

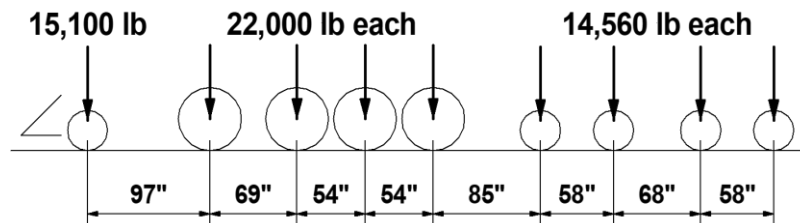
Fig. 3. Design locomotive axle loads as given by the 1881 O&W *General Specification for Iron Bridges*.

As noted earlier (and as reflected by Fig.'s 3 and 4), the design live load of the O&W specification is somewhat close to a Cooper E22, and was therefore almost at capacity with an overall rating of E22.6 (based on this specification). After the bridge went into service in 1882, the actual train loads gradually increased over the structure's 15-year life, and by the 1890's the bridge was routinely subjected to loadings in excess of Cooper E29. This load level exceeds even the overall rating based on the current AREMA standards of Cooper E25.7. Thus, based on either measure, the bridge was regularly subjected to overloads in the years leading up to its 1897 collapse.

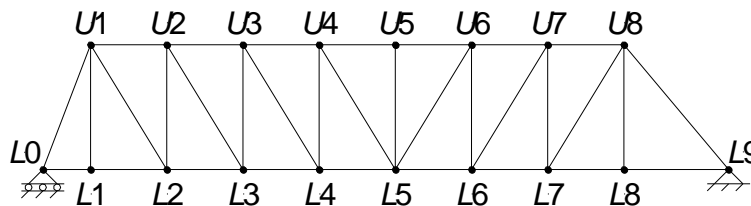
Fig. 5. Truss configuration.

Figure 5 shows the general arrangement of the truss and the nomenclature used for each panel point. When analyzing the hangers, the significant skew of the trusses was accounted for in the loads on each rail, and since the hangers are only affected by first-panel loads, the skew did result in a small difference in hanger force. When analyzing the rest of the truss, however, the skew's influence on rail loads was not included, as its effect is negligible. This was because the bulk of the truss members were affected by loads applied to all panels, and that the effects of the skew at one end of the span tended to balance out the effects at the other end.

Based on the capacity assessment and comparative analyses of the present study, hanger *U8-L8* in particular does display a rather low rating of Cooper E24.4 based on the O&W specification, although there are a number of members that do exhibit a slightly lesser rating. Consistent with the apparent practice of the designers, however, the rating of the hanger was based on the gross section only, even though the O&W specification clearly indicates that the loss of section through the riveted connection should be taken into account. When applying this condition, member *U8-L8* only rates at Cooper E14.4, far below the overall rating for the truss at E22.6.
