Use of Aircraft Crash Cases in Teaching Engineering

Patrick H. Oosthuizen

Abstract

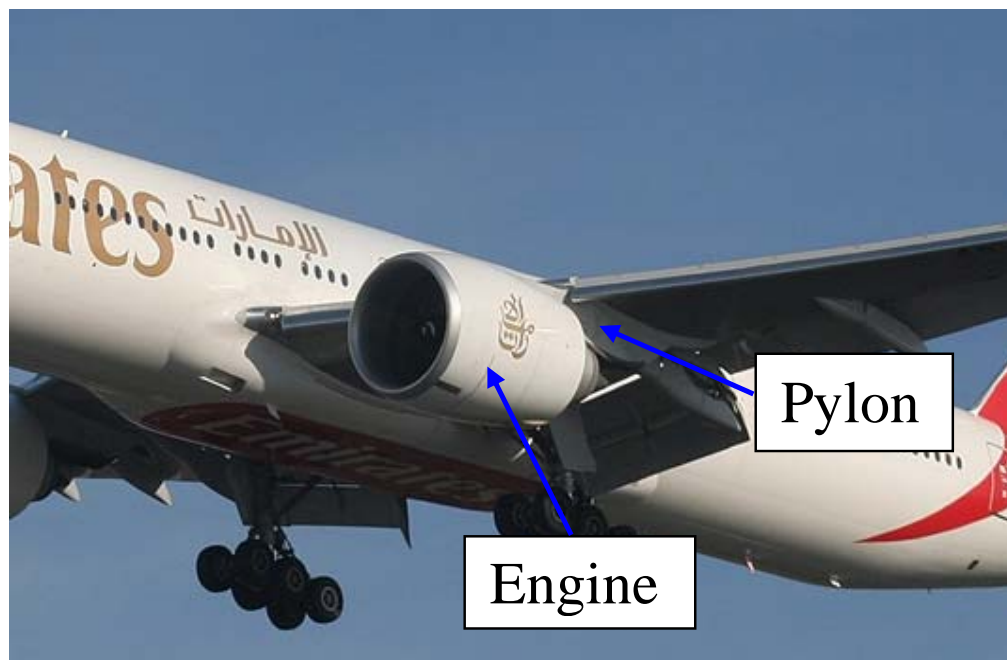
Figure 1. Typical Engine and Pylon Arrangement

The accident investigation also revealed, on recovery of the engine/pylon assembly, that there was a fracture on the rear bulkhead on the pylon. Eight weeks before the accident, the aircraft went through a major check and the self aligning bearings on the bulkhead to wing attachment joints were changed. The normal procedure for doing this would have involved separately removing the engine and pylon from the wing using a special cradle to lower the engine. To save time, however, a new procedure had been adopted. This involved the use of a forklift truck to take the whole engine plus pylon assembly off as a single unit. When the assembly was being put back on to the wing, a disagreement occurred between the mechanic and the forklift driver and a sound like a gun shot was heard, this being the result of the fracture of the pylon bulkhead. Unknown to the mechanics, the aircraft was put back into service with a weakened pylon assembly that failed under normal load conditions on the afternoon of Friday May 25, 1979.

- The vulnerability of pylon attachment points during maintenance, and of the leading edge slat system which produced asymmetry.
- Deficiencies in the FAA's surveillance and reporting systems which led to its failure to detect improper maintenance procedures.
- Deficiencies in communication between the aircraft operators, McDonnell Douglas, and the FAA in failing to provide details of previous maintenance damage.
- Crew procedures to cope with unique emergencies.

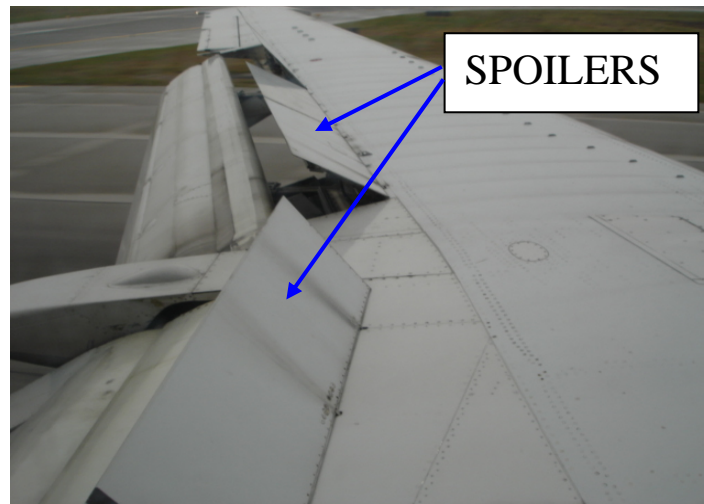
Figure 2. – Typical Spoiler Arrangement

Air Canada Flight 621: Air Canada Flight 621 from Montreal, Quebec to Toronto, Ontario on July 5, 1970 was operated using a McDonnell Douglas DC-8 Super 63. From Toronto the flight was to proceed on to Los Angeles. On the approach to Toronto the Captain and First Officer agreed on a procedure for the deployment of the spoilers which are lift reducing devices on the aft portion of the wings (see Fig. 2 – the spoilers are sometimes loosely referred to as air-brakes). The deployment of the spoilers involved two actions, the first being the arming of the spoilers so that they were ready for deployment and the second was their actual deployment. The flight crew decided that the spoilers would be armed during the flare just prior to touch-down. This would allow for the automatic deployment of the spoilers when the wheels made contact with the runway. This was not the procedure specified by Air Canada but a number of flight crews were not following this specified procedure. When the aircraft was at an altitude of about 20m above the runway and had passed over the start of the runway, the Captain called on the First Officer to arm the spoilers. This required the First Officer to lift a lever on the control console. Unfortunately, he instead pulled the lever to the rear which resulted in the immediate deployment of the spoilers. As a result of the consequent lift decrease, the aircraft started to descend at a high rate towards the runway.

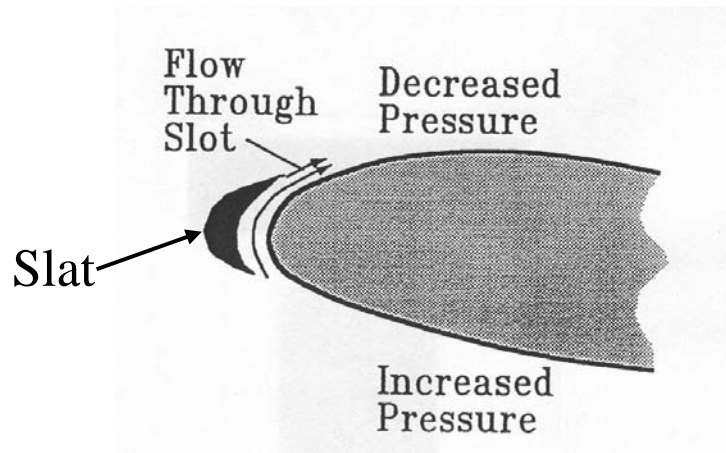
Figure 3: Leading Edge Slat on a Wing

Subsequent investigation revealed that the cause of the incident was the inadvertent deployment of the leading edge slats (see Fig. 3) which are normally only used during landing and possibly during take-off. The pitch oscillations were the result of trying to regain control. The basic cause of this inadvertent slat deployment was the poor design of the flap/slat actuation handle that could be easily and inadvertently dislodged from cruise flight position. It was found that at least five other incidents involving inadvertent slat deployment with MD-11 aircraft had occurred. As a result of this incident, design modifications to the flap/slat actuation handle were ordered.
