Engineering Standards and Product Liability

Richard E. Forbes, Ph.D., P.E. and Mary C. Emplincourt, M.S., M.A.

Mississippi State University

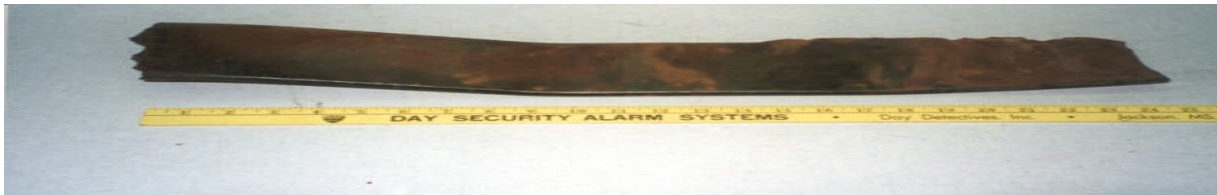
In 1998 Camilla Haynes was killed when a 13-pound blade (Fig. 1) broke loose from an industrial rotary mower and flew through the windshield (Fig. 2) hitting Haynes in the chin and throat area, crushing her jugular vein and spine. Driving along I-55 in Jackson, Mississippi, Mrs. Haynes, the driver of the vehicle, was traveling from her home in Arkansas with her children and mother to a family vacation in Florida when the accident occurred. Two years later a Mississippi jury, in federal court, returned the largest known damage award (\$12 million) in the state's history to the Estate of Camilla Haynes. The defendants named in the lawsuit were the blade manufacturer, the manufacturer of the industrial mower, and the company that the Mississippi Department of Transportation had contracted to mow the grass. In the informal investigative phase of the matter, the expert witnesses determined that the blade and mower manufacturers had not complied with the appropriate published standards. Furthermore, the expert witnesses stated that the mower manufacturer had not followed sound engineering practices.

Figure 1. Example of Blade that Struck Mrs. Haynes

The Haynes trial lasted two weeks with two hours of deliberation in which the jury returned a verdict against the blade and rotary mower manufacturers. In the \$12 million settlement the jury found that these two manufacturers produced unreasonably dangerous products and held them willfully liable for damages to be shared equally. In a second damage-only trial the award was reduced to approximately one half of the original settlement. The rotary mower manufacturer had inadequate control over its product and ignored information that the blade would break. In addition, the mower manufacturer failed to exercise reasonable quality control in that it sold an agricultural rotary mower for non-agricultural use without equipping it with a device to keep items from flying out from beneath it. The blade manufacturer acknowledged that the blade sold to the mower manufacturer had a small crack in it that couldn't be seen with the naked eye. The blade broke off at the hairline crack that was not detected during manufacture. The crack was caused by improper heat treatment.

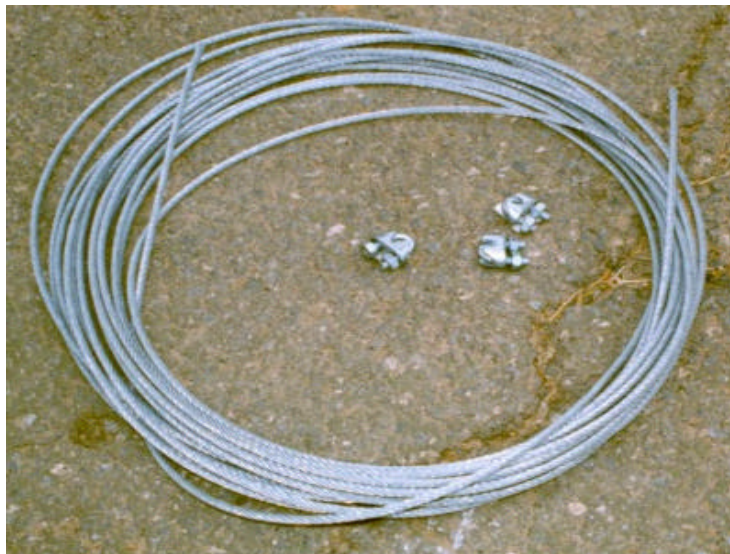
A mower was purchased and tested following addition of the aircraft cable to only half of the mower. The cable and associated clamps seen in Fig. 6 were purchased at a local building supply for approximately \$30. Figures 7 (a), (b), and (c) show how the cable was added to the chain curtain. A one-day testing of the mower (video tape produced for evidence) clearly showed that there was no discernable difference in operation between the modified and unmodified halves of the mower.

Figure 6. Cable and Clamps

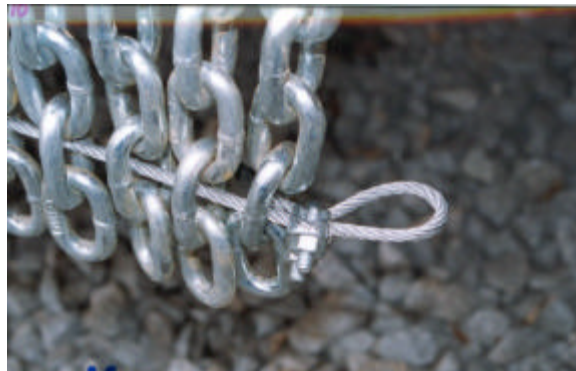
Figure 7 (a). A Close-up View of a Cable and Clamp Threaded through Chain Guard

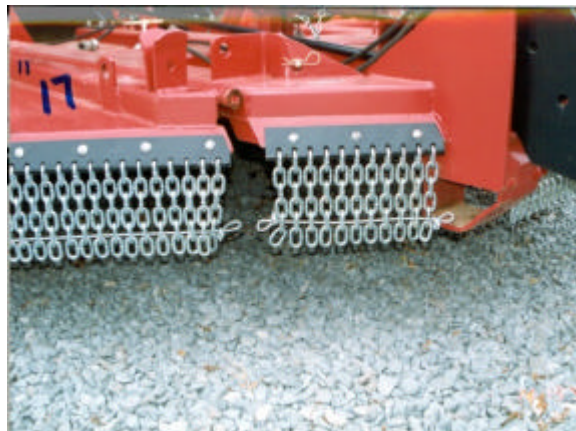
Figure 7 (C). Cable and Clamps Threaded on Both sides of the Mower's Guard

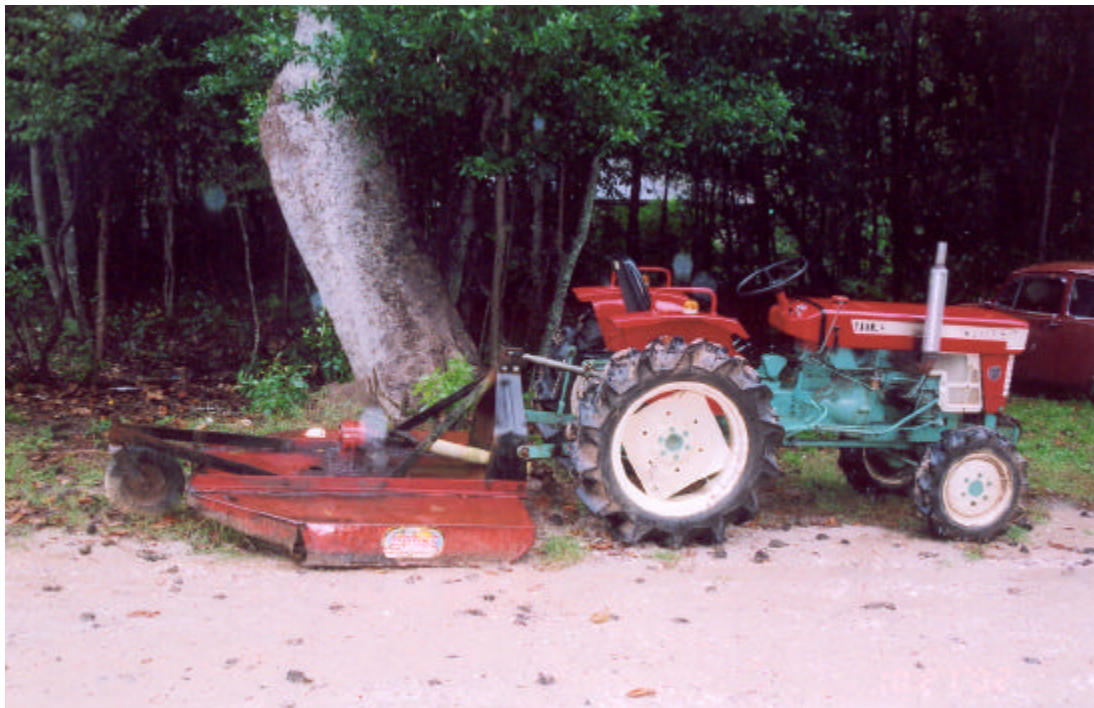
Figure 8 shows the tractor and mower, as it was located at the time of the accident. Each of the two blades is attached to the rotary member ("stump jumper") using a single bolt and is allowed to pivot freely about the bolt. In this instance, the blade broke through the bolt hole (as in Haynes) and penetrated the steel deck prior to hitting the tree.

Figure 8. Tractor and Mower before the Accident

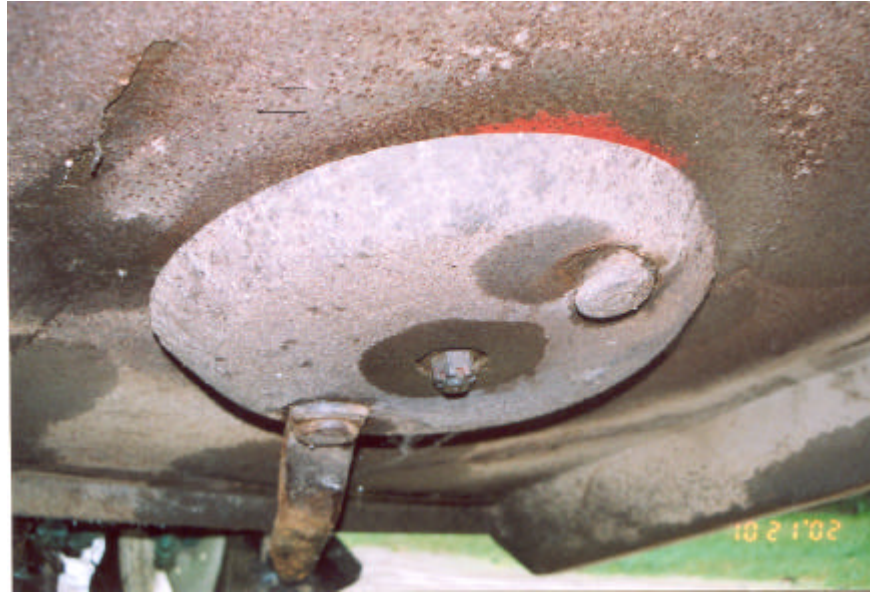
Figure 9 shows the rotary element with attached single blade and the blade bolt that attached the thrown blade.

Figure 9. The Rotary Element Underneath the Mower after the Accident

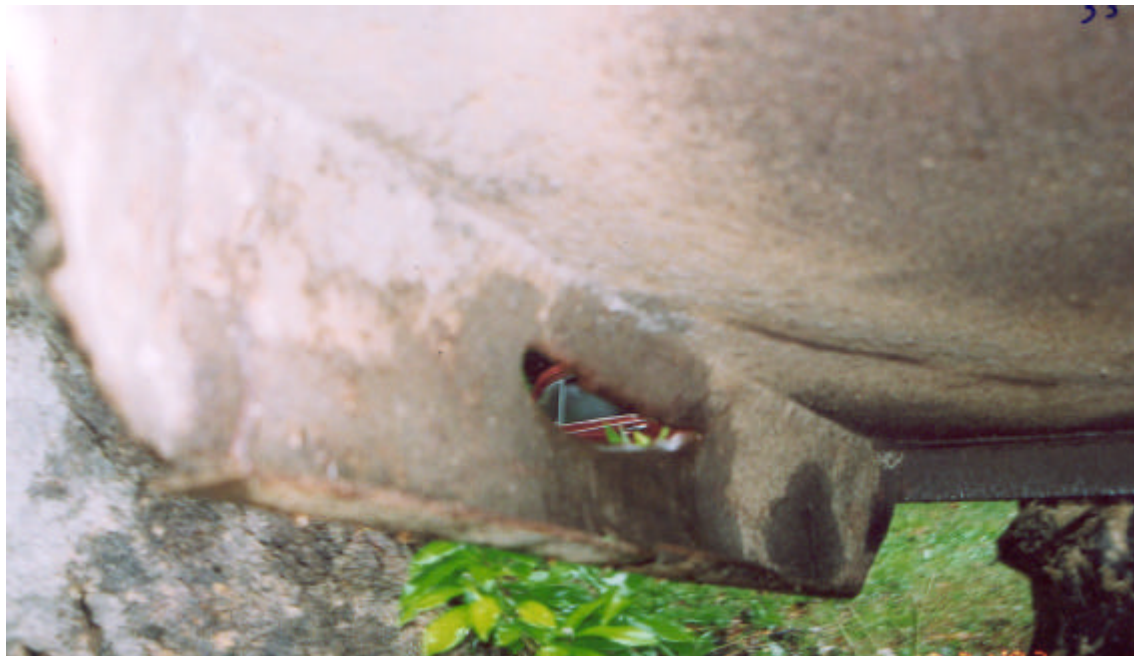
Figure 10 shows the gash in the steel mower deck that allowed the blade to leave the housing.

Figure 10. The Gash in the Mower Housing Where the Blade Exited

The relevant standard issues for the second accident are the blade ductility (as in Haynes) and those portions of the rotary mower standard (SAE J232), which deal with the integrity of the steel deck (Structural Integrity Tests).
