## **Analysis of Existing Building Structures Using Laser Scanner and 3D Models**

# **Analysis of Existing Building Structures Using Laser Scanner and 3D Models**

## **Abstract**

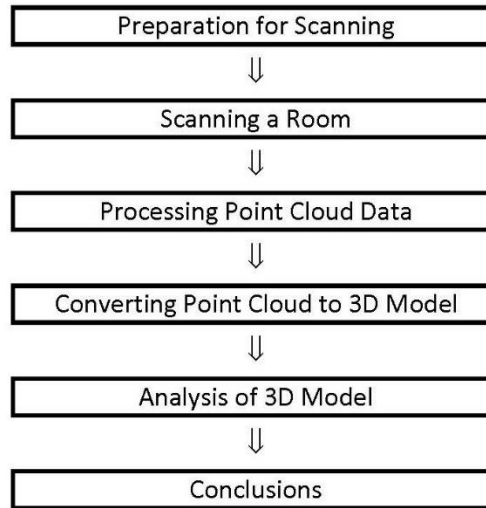
Figure 1. Methodology of Study

This study employs a 3D scanner to conduct a case study by scanning a room within a university campus building. Figure 1 illustrates the procedures and methodology of this study. The paper details the procedures for point cloud data collection and measurements of the existing building using the point cloud data, and it discusses the results of the comparison between the point cloud data and in-situ measurements.

This section details the procedures for point cloud data acquisition using a commercial 3D scanner. As illustrated in Figure 1, the procedures encompass preparation for scanning, scanning itself, post-processing of scanned images, and 3D modeling of a room. Among the various strategies for object scanning, this study employs target-based scans. This choice allows for the processed point cloud data to be registered using target-based registration in the commercial software, Trimble RealWorks.

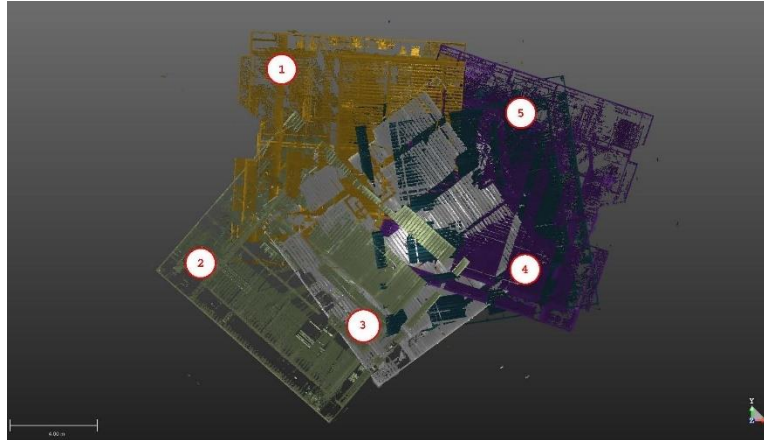
Figure 2 Scanned Images before Registration (Top View)

Once scanning is complete, the collected point cloud data is registered for post-processing in RealWorks. This study utilizes five different stations, each producing a set of point cloud data. Therefore, the point clouds from these stations must be properly aligned. Figure 2 illustrates the five sets of point clouds (marked by numbers counterclockwise) before they are processed for the next step.

The scanning equipment assumes an arbitrary coordinate (X,Y, and Z = 0,0,0) for station 1, and the author registers or moves the other stations to align with station 1. For large projects, users can choose to georeference scans to a common datum or reference, such as the State Plane Coordinate System, to meet larger project requirements.

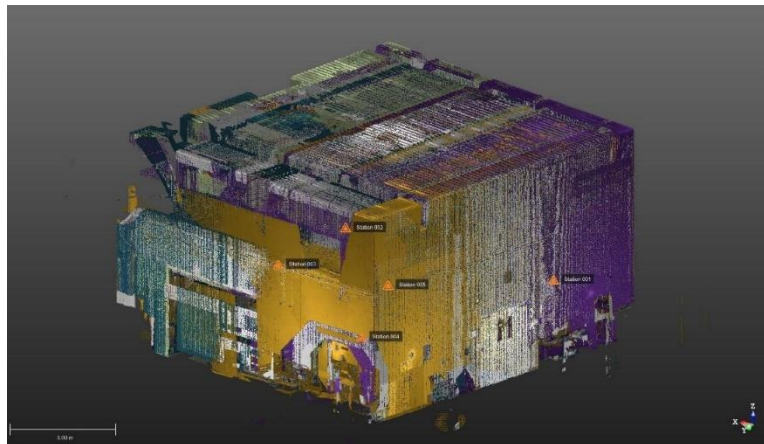
Figure 3 Registered Point Cloud in RealWorks (3D View)

As mentioned previously, this study scans a university campus building, opting for target-based registration in RealWorks without georeferencing. Figure 3 shows the merged point cloud after the registration is complete.

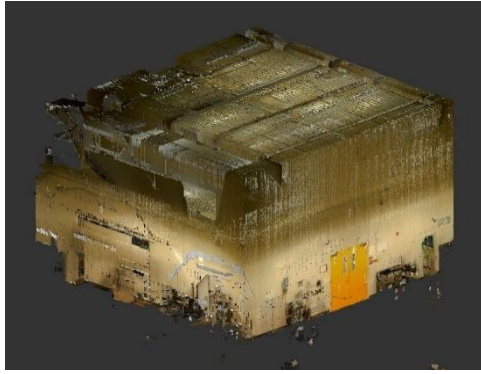
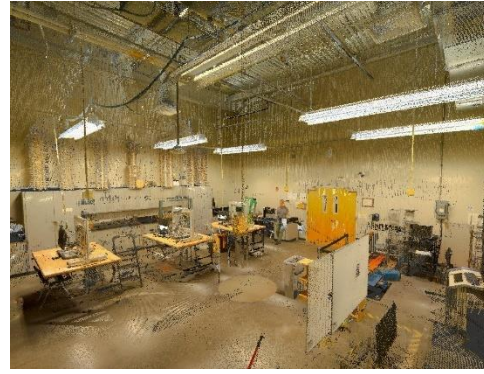
Figure 4 Imported Point Cloud in Recap

Once the point cloud data are registered and processed, they can be converted into a 3D model using Autodesk Recap Pro and Revit software packages. The process involves two main steps. First, the registered point cloud data from RealWorks is exported to Recap Pro. This step is crucial as it converts the point cloud data into a format compatible with Revit. Figure 4 illustrates the (a) exterior view and (b) interior view of the scan in Recap Pro. Second, the point cloud data from Recap Pro is imported into Revit, where it can be viewed in different perspectives, such as plan view, elevation view, and cross-section view.

(a) Exterior View

(b) Interior View

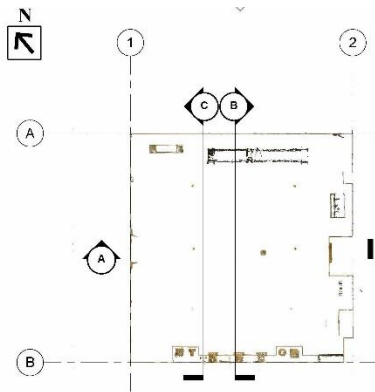
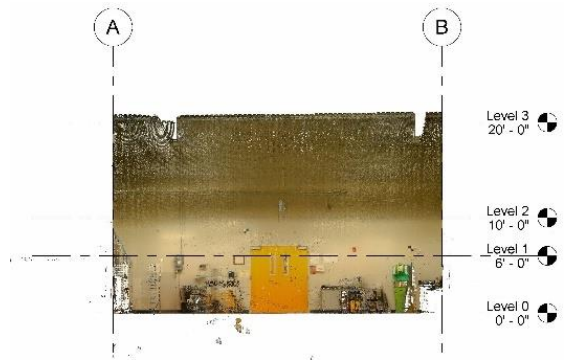
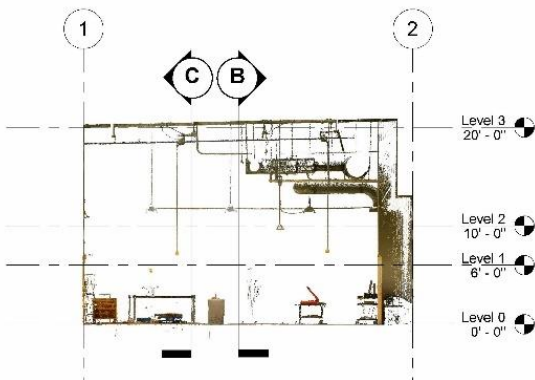
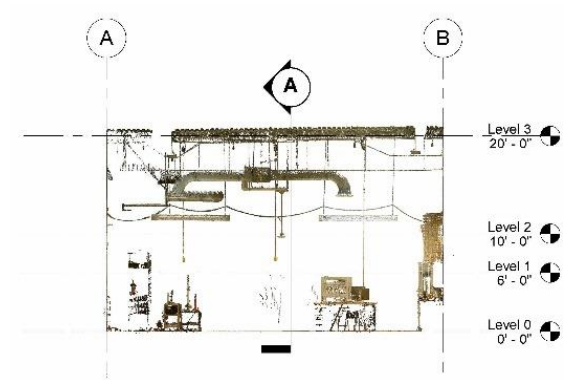
Figure 5 3D Model in Revit

Figure 5 presents four distinct perspectives: (a) a plan view, (b) an elevation view, (c) cross section A, and (d) cross section B. These views can subsequently be utilized for measuring room elements and conducting quality assurance of the point cloud data by comparing it to in-situ measurements in the subsequent phases of this study.

(a) Plan View

(b) Elevation View

(c) Cross Section A

(d) Cross Section B

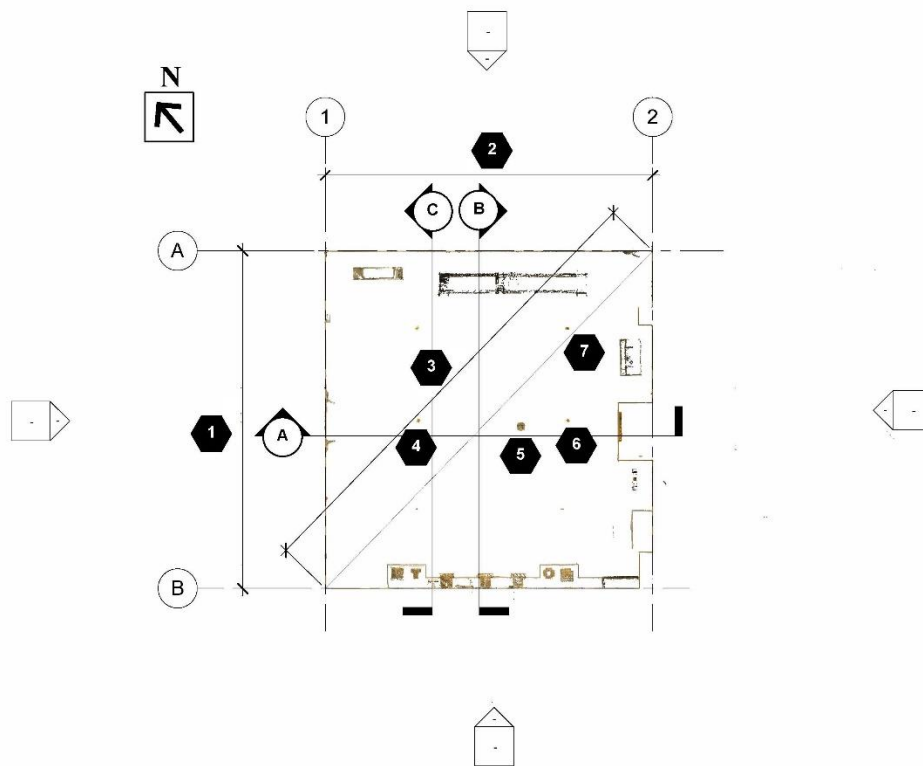
Figure 6 Plan View of Room

This study involves 30 randomly selected data points within the room, comprising three horizontal distance measurements on the floor and 27 spot elevations. For instance, Figures 6 through 8 illustrate seven points arranged in a hexagon for each respective view. Table 1 presents a comprehensive data set used in this study, comparing point cloud data with in-situ measurements using a total station.
