Bridge Building in the Colorado Rockies: A Mechanical Engineering Major's Perspective

**C1C Ryan J. Howe, Dr. Stanley P. Rader, Lt Col Matthew P. Snyder
United States Air Force Academy**

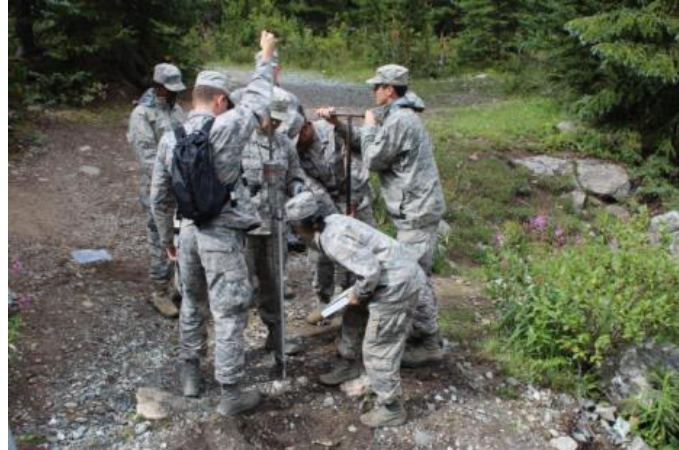
Figure 1. Dynamic Cone Penetrometer Tests at the McCullough Gulch Bridge Site

The Geotechnical team was concerned with the soil composition and its overall load bearing capabilities. Pretty quickly, I started to see the discontinuity between me as a Mechanical Engineering major and the rest of the team of Civil Engineering majors. Many of them were in a geotechnical engineering class and other relevant classes to prepare them for a site visit like this. Simply put, they often knew what was going on much more than myself. They used a Dynamic Cone Penetrometer to measure the “give” of soil as depth increased, seen performed in Figure 1. After recording these values, they collected various samples of the soil for use in the lab and further testing. This data would be used to determine if the soil could support the new bridge we planned to build.

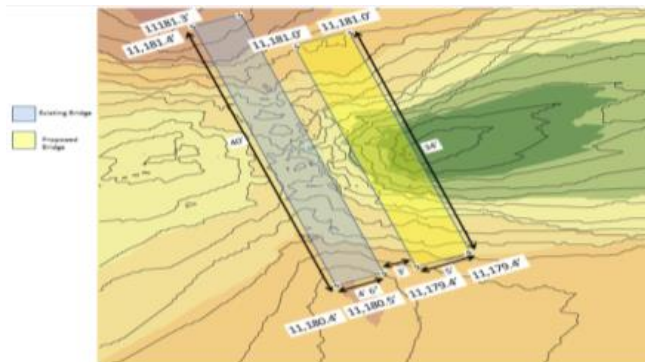
Figure 2. Completed survey map of old and new bridge locations

The surveying team worked with one of the technical experts in the Civil Engineering Department, as well as a few members from the structural subdiscipline team. Using a Trimble surveying instrument, they mapped out the topography of the surrounding area, as well as the stream below the bridge site. Sparing the technical details (which are not covered in Mechanical Engineering), the team provided a topographic map to the class, outlining the where the new bridge would be placed and the elevation changes across the site area. This map can be seen below in Figure 2.

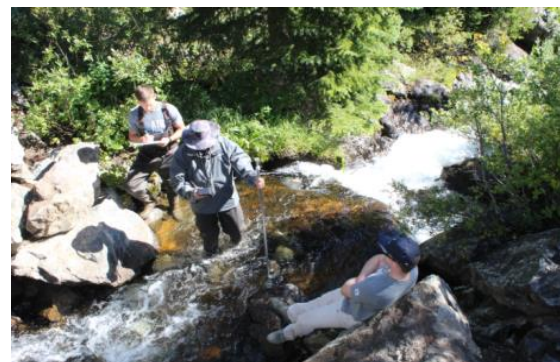
Figure 3. Stream flow rate tests during the site visit

The hydrology team, of which I was a part, needed to identify the 100-year flood event flow rate and flood boundaries for the stream in order to safely position the bridge. In order to do so, this required taking flow rate measurements at various points along the river. One measurement was taken far upstream and the other was taken just below the existing temporary bridge. This test involved measuring the width of the stream, parsing this width into sections, and measuring the velocity of the propeller that was submerged in the water.

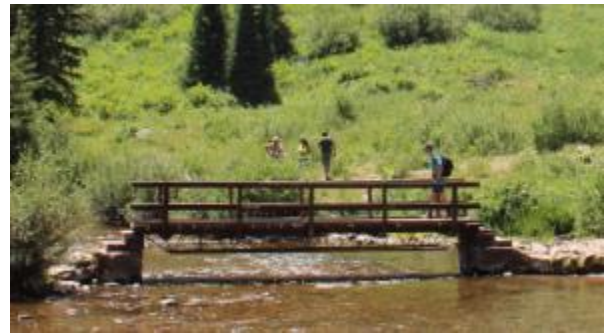
Figure 5. Open web steel joist bridge type located at Maroon Bells. Note the cord and web members beneath the bridge

The cadet team looked at primarily two designs: the open-web steel joist and the glulam beam design. Figures 5 and 6 highlight the differences between the two, and certain factors influenced the team's bridge type selection.

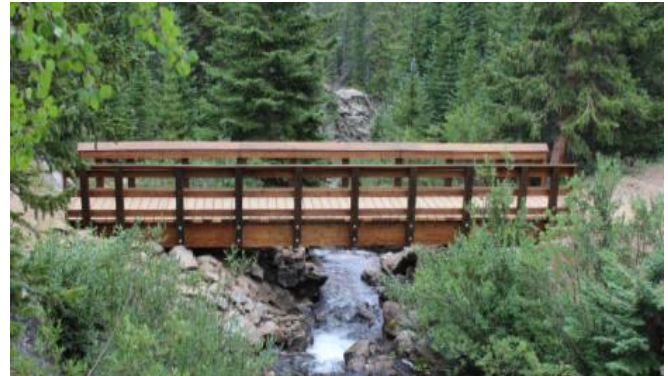
Figure 6. Glulam beam design at McCullough Gulch

The course focus then narrowed to the design characteristics of the glulam beam bridge. We had to identify which wood to use for the stringers given altitude, humidity, wetness, and loading factors. Knowing this allowed the team to optimize the solution and not “over-engineer” where unnecessary. These calculations incorporated the loading conditions solved for earlier in the semester and resulted in a stringer design of 3.125”x21” of Alaskan Yellow Cedar, which could safely carry the loads and was environmentally acceptable – resulting in an economical design. After the stringer design was completed, the deck, handrail, and handrail posts were designed. We were provided a starting point since we planned to use the same design as the Maroon Bells bridge, constructed two years prior. This made the calculations more of a check that the previous design would work given the loading conditions, and not so much of an original design. The design was based on the Forest Service’s *Transportation Structures Handbook*, with design calculation specifics based on the American Wood Council’s *National Design Specification for Wood Construction* and the accompanying *NDS Supplement*. Calculations confirmed that 2”x6” Douglas Fir Larch wood members would suffice for the railings and rail caps on the bridge. The rail posts also required a check on loading and involved a similar method to the railings. The *Transportation Structures Handbook* provided the loading on the post and resulted in using a 6”x6” Douglas Fir Larch No. 1 wood timber for each of the posts on the bridge. These design calculations concluded the “number crunching” portions of the project, but still

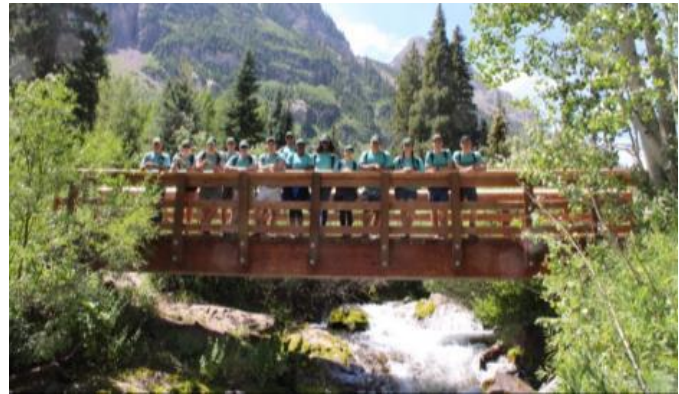
Figure 7. Maroon Bells glulam beam, constructed by USAFA Class of 2017

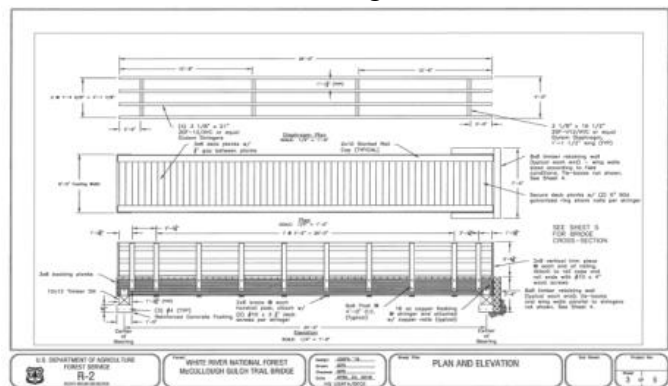
Figure 7. One of the pages from the approved plans used during the construction of the bridge.

significant work remained to prepare for the quickly approaching summer construction period. Draft construction plans and specifications were produced, which went through several iterations. After valuable and enlightening review comments were received and responded to, the Forest Service approved the revised plans and specifications, and the cadet team moved on to construction planning and scheduling.

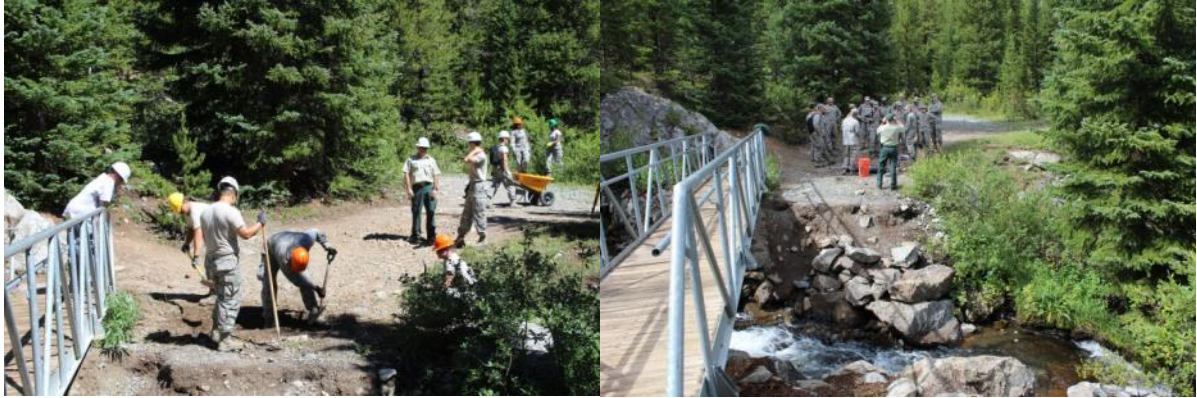
Figure 10. “By-hand” excavation of the north side of the bridge

Figure 9. Location of the new bridge site on day one

up the work and began excavating (by hand) the abutment on the far side of the stream and constructing the field latrine. The excavation was tedious – it was apparent that the soil at the abutments were more rock than dirt, making the progress pretty slow. Adding to the slow progress was the amount of people ready to help on the project. The 13 cadets ready to help sometimes translated to a lot of standing around since only a few people could be working in the hole at once. Everyone did get their fair share of digging, and even the token Mechanical Engineer had some time in the dirt – although I didn’t help my case when the one time I did dig, a rock flew up from the dirt and hit me square in the eye... Not a great look for the “team lead” on the first day, no pun intended. This made safety a much larger focal point for the whole team moving forward, and we stressed the importance of wearing personal protective equipment (PPE) when required. Thankfully, no other injuries occurred after this (at least while working on the project); weekends spent mountain biking was a different story.

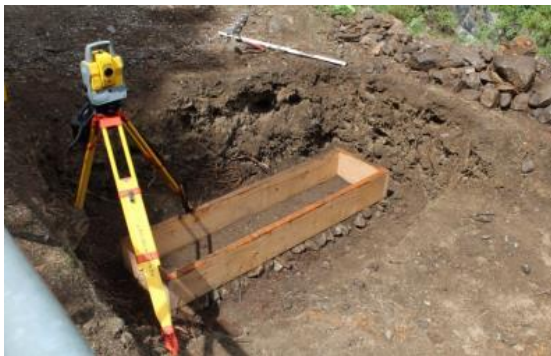
Figure 12. One of the bridge abutments with a concrete form in place

Following the excavation, the team formed and placed the concrete footings on which the stringer bearing shoes would rest. This was important since the concrete had to cure to develop its strength prior placing the four, 500 lb. stringers on top of the abutments.

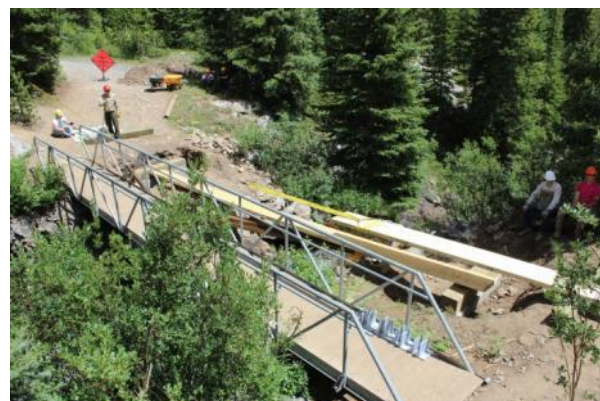
Figure 14. Rigging setup used to lift the stringers across the stream

much looking to mitigate. The rigging portion involved a set of anchor points, one on each side of the river. Hand winches were set on each side of the stream bank, one to pull the cable to slide the stringer across, and one to relieve tension in the cable for when the stringer was moving. This process was repeated four times, for each of the four stringers, which were then placed in the bearing shoes on the abutments. With the stringers in place, the bridge started to take shape! Once the stringers and shoes were attached to the abutments, installing the diaphragms was next. The diaphragm pieces provided rigidity and lateral stability to the stringers and were placed perpendicular to each stringer along the length of the bridge. We all expected them to go in much quicker, but soon began to realize the tedious assignment that was ahead. Each diaphragm had face mounting brackets, which were nailed into both the diaphragm and the stringer. Each face

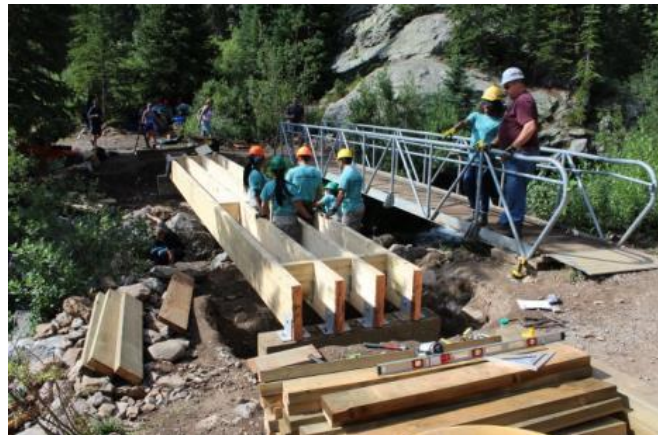
Figure 15. Stringers in place with diaphragms being installed

had seven slots for nails, for a total of 14 nails per side. The difficulty was twofold: the wood used for the diaphragm was relatively hard, so the satisfying feeling of completing a nail in three hammer swings was nonexistent— this often led to bent nails or nails that would just get stuck in the wood, causing a lot of frustration. Predrilling the holes only helped when the mounting bracket wasn't installed – the drill would get in the way of the stringers, so the correct holes could not be accessed. Additionally, the few nails that could be swung at were located in such a way that it was nearly impossible to have any room to move the hammer – a combination of the stringer/diaphragm joint location, as well as having to sit uncomfortably on the stringer to complete the hammering. At Maroon Bells, the team was only allowed to use framing hammers due to the wilderness requirements; we only had framing hammers but were not restricted to them. As the frustration intensified, part of the team was dispatched to retrieve pneumatic palm nailers, which made a very frustrating task much easier. With the diaphragms installed, the four pieces of wood that spanned the river were now turning into a bridge!

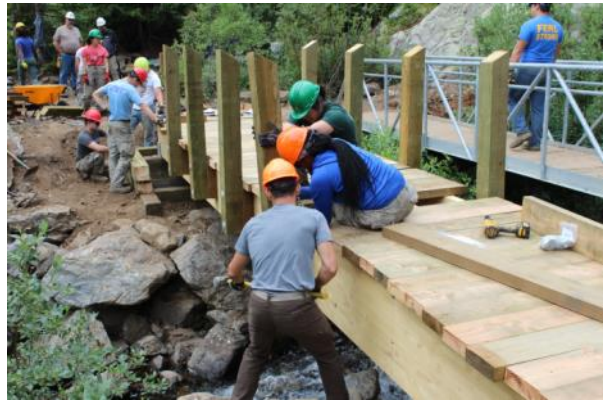
Figure 16. Decking and rail posts are being installed

Once the diaphragms were installed, backing planks were attached to the ends of the stringers, which were protected with copper flashing to help mitigate deterioration due to moisture. Bridge decking was placed atop the stringers, aligned, and predrilled for the screws that would secure them to the stringers. Meanwhile, the predrilled rail posts were installed, and large timber bolts were inserted into the holes drilled through the posts and stringers. It was absolutely required that these holes be plum, level, and straight – any error would prevent the rail post from attaching to the stringer or being placed out of plumb and look bad. As we began installation, we realized our method of drilling was not precise enough – the inserted bolts would not go in straight and would not fit into the holes on the stringers. To fix our error, the team bored out extra material from the post to make sure there was just enough “wiggle room” to allow the timber bolts to successfully attach the posts to the stringers. A day later, all posts were fixed and installed!

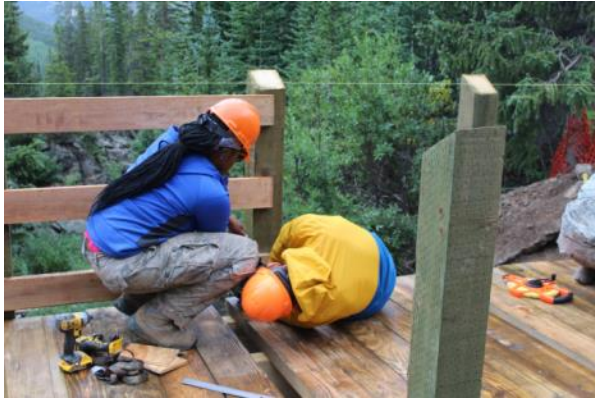
Figure 17. Railing measuring and installation

The team made spacers to make the process go quickly for the spacing, and with decking proceeding from both sides simultaneously, the construction process began to look like a well-oiled machine. As half of the crew was decking, the other half was installing the railings on the posts. These were tricky since they had to be level to the bridge, to the eye, and to one another. While not super difficult, it required some thinking ahead to make sure that the handrails were in the right spot laterally, as well as high enough on the posts. A challenge at this part was dealing with some of the warped wood. We attempted to straighten the wood out by pulling on the members with tie-downs, but even then, it was not perfect. This was the unfortunate reality of working with imperfect wood, but the team tried as much as possible to mitigate the undesirable aesthetic. After these tasks were complete, rail caps were installed on the posts. Considerations as to which side should be facing up were made to help reduce splinters, as well as maintain the best possible handrail appearance. It was important when drilling these in that the screws would intersect the top railings, which provided a 1.5” target width to hit – not easy when the rail caps were at an angle and of the same thickness. As the rail caps were installed, the retaining walls were filled and compacted to create a level approach from the trail to the bridge deck. As we were finishing the rail caps, we realized we were short on screws! We were missing seven screws needed to complete the bridge. After looking for the screws to no avail, we began disassembling the field latrine that we had built on the first day. Lo and behold, seven screws were used in the construction of the latrine. Mystery solved.

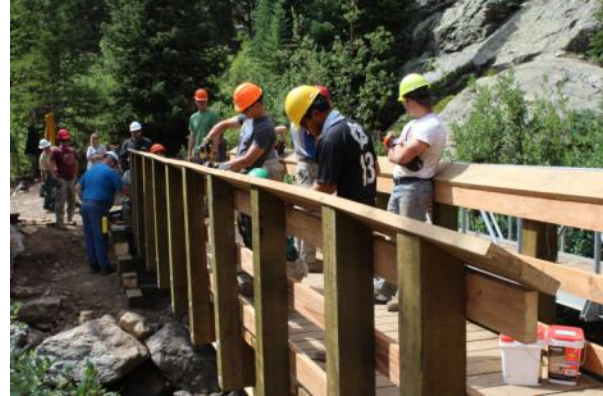
Figure 18. Railings and rail caps installed

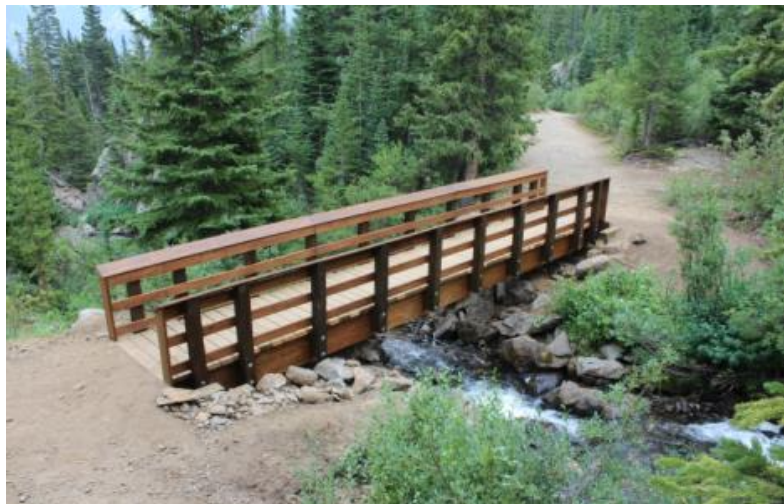
Figure 21. The finished product at McCullough Gulch trail. Built by USAFA Class of 2019 cadets
