ENGINE AND DYNAMOMETER SERVICE AND FUEL CONSUMPTION MEASUREMENTS

ABSTRACT

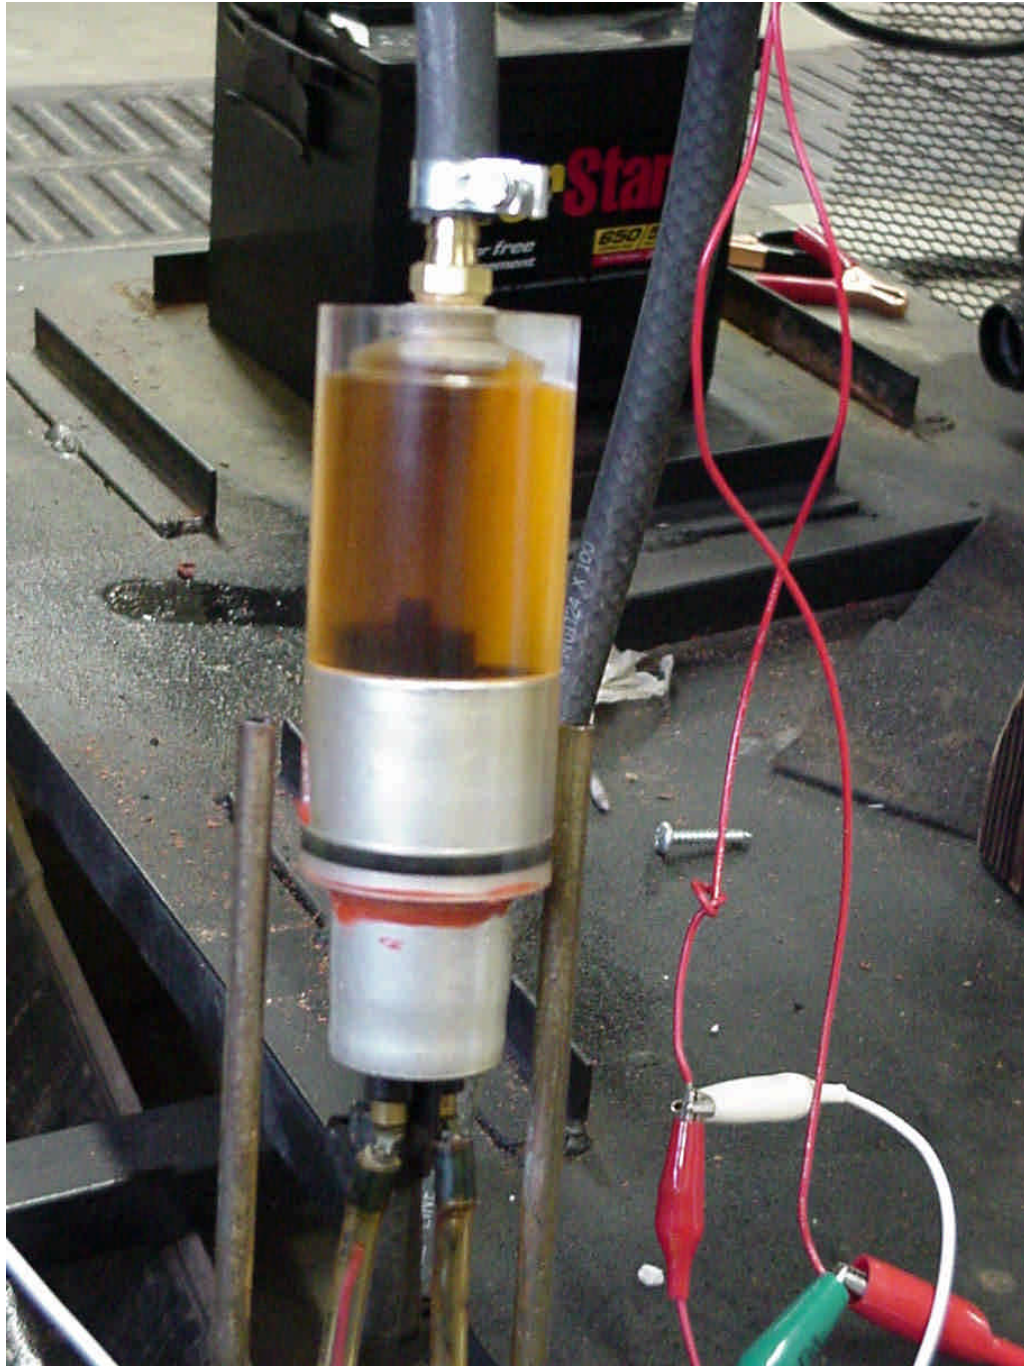
Figure 1. New Fuel Tank (at top) and Old Fuel Pump (at bottom).

plexiglas, transparent fuel tank (1.5 in. ID and 2 in. long) which was attached to the fuel pump as shown in Fig.1. The other end of the tank was connected to two burettes through a two-way valve. Originally, the overflowing fuel from the fuel injector system was returned back to the 250 ml (30 mm ID, 40 cm long) measuring burette. Later, since air accumulation in overflow return tube caused volume measurement errors, fuel overflow was prevented using the method described below. 500 ml (40 mm ID, 50 cm long) burette is used as a regular fuel tank. For measurements, both burettes were filled with gasoline before the start of the measurements. Engine was warmed up and adjustments were made while fuel was being consumed from the 500 ml burette. Then, fuel use was switched to 250 ml burette and data was taken while fuel was consumed from 250 ml burette. At low engine speeds and loads, time for 50 ml fuel consumption was measured. To minimize the timing errors at high speeds and loads, 100 ml fuel consumption was used. This way timing errors was kept below about 2% (half a second in 30 seconds of timing). Since measuring tube is graduated at intervals of one cc, reading error in volume is less than 1% (Maximum 0.5cc in 50cc of timed volume).

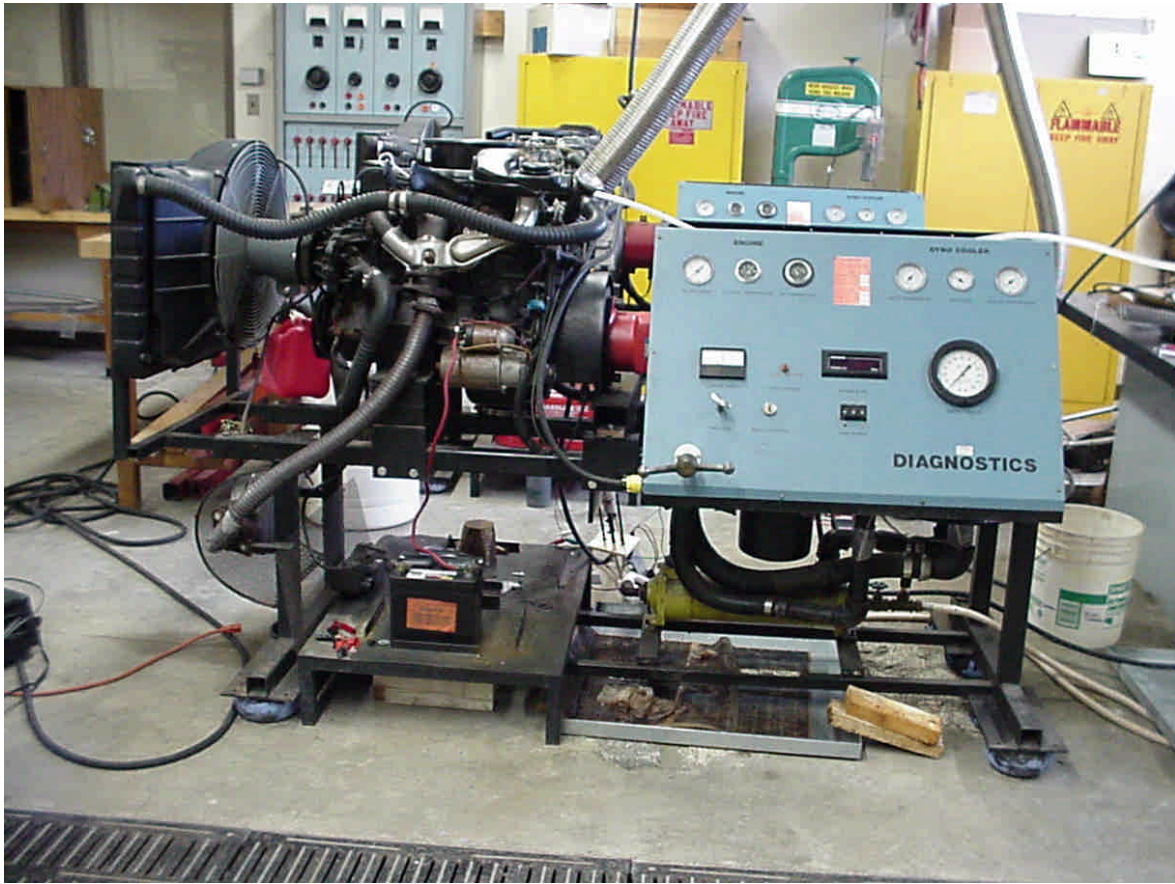
Figure 2. Megatech Engine and Dynamometer System.

Injector pressure is same as outlet pressure of the old fuel pump. Rheostat is adjusted, as needed, to keep the outlet pressure of the old fuel pump between 9 and 9.8 psi. Fig. 2 and Fig. 3 are two pictures of the engine-dynamometer system.

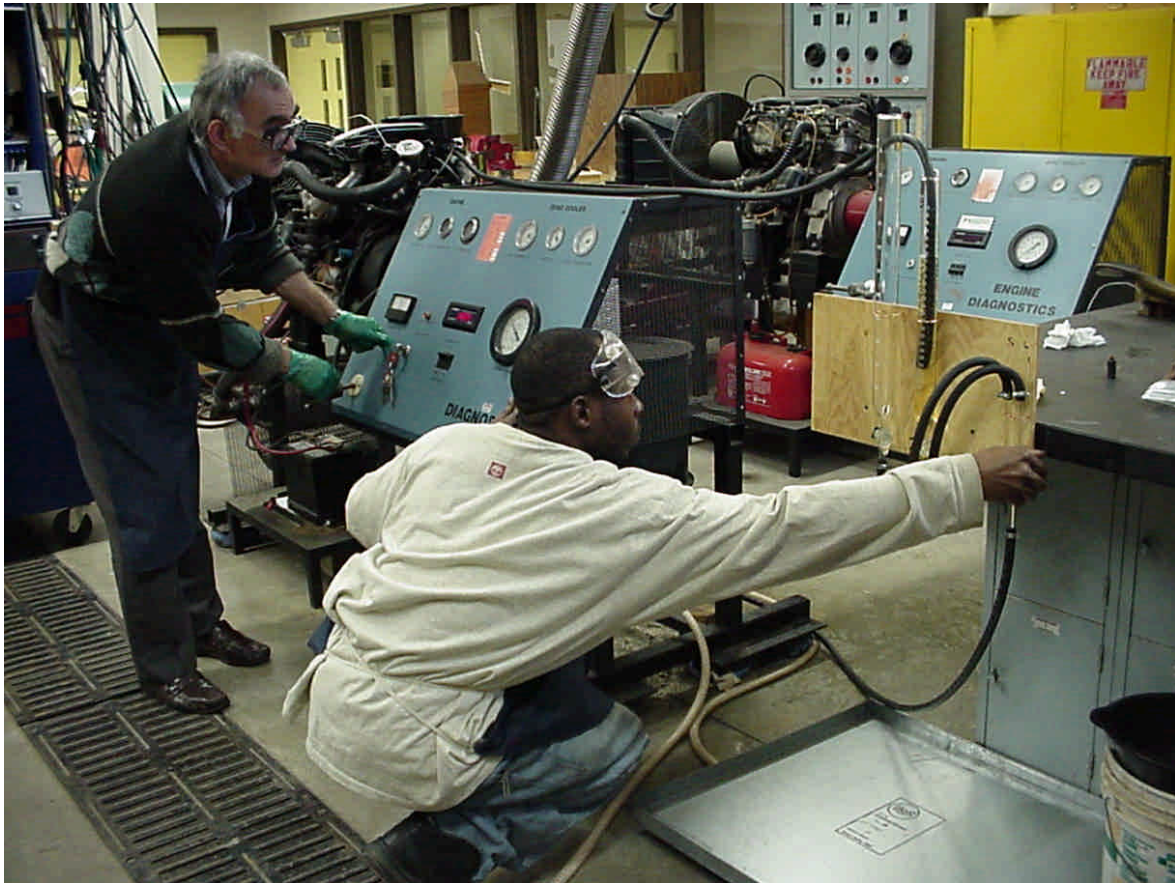
Figure 3. Dynamometer and Volumetric Fuel Measuring System.

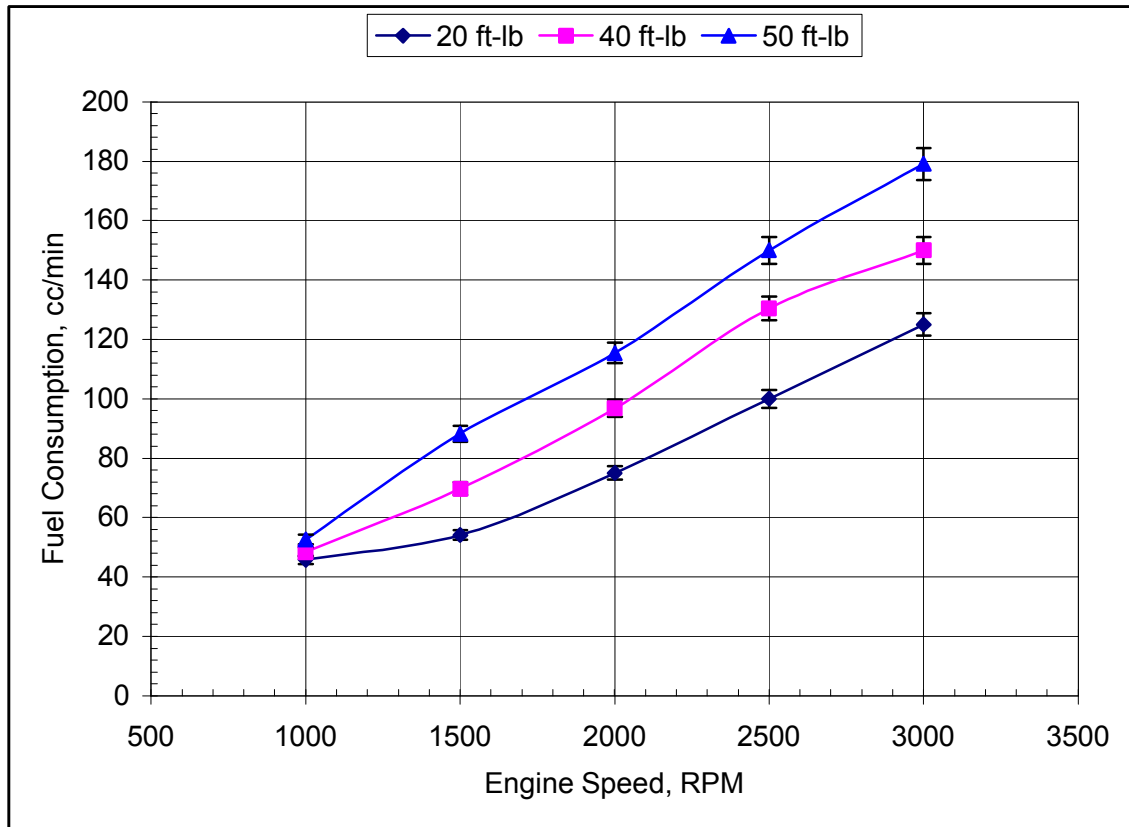
Figure 4. Fuel Consumption as a Function of Engine Speed

Graphs of the fuel consumption as a function of engine speed and engine load are given in Fig. 4 and Fig. 5. As seen from the graphs, as expected, fuel consumption rates are higher for higher engine speeds and for higher engine loads. An interesting graph is

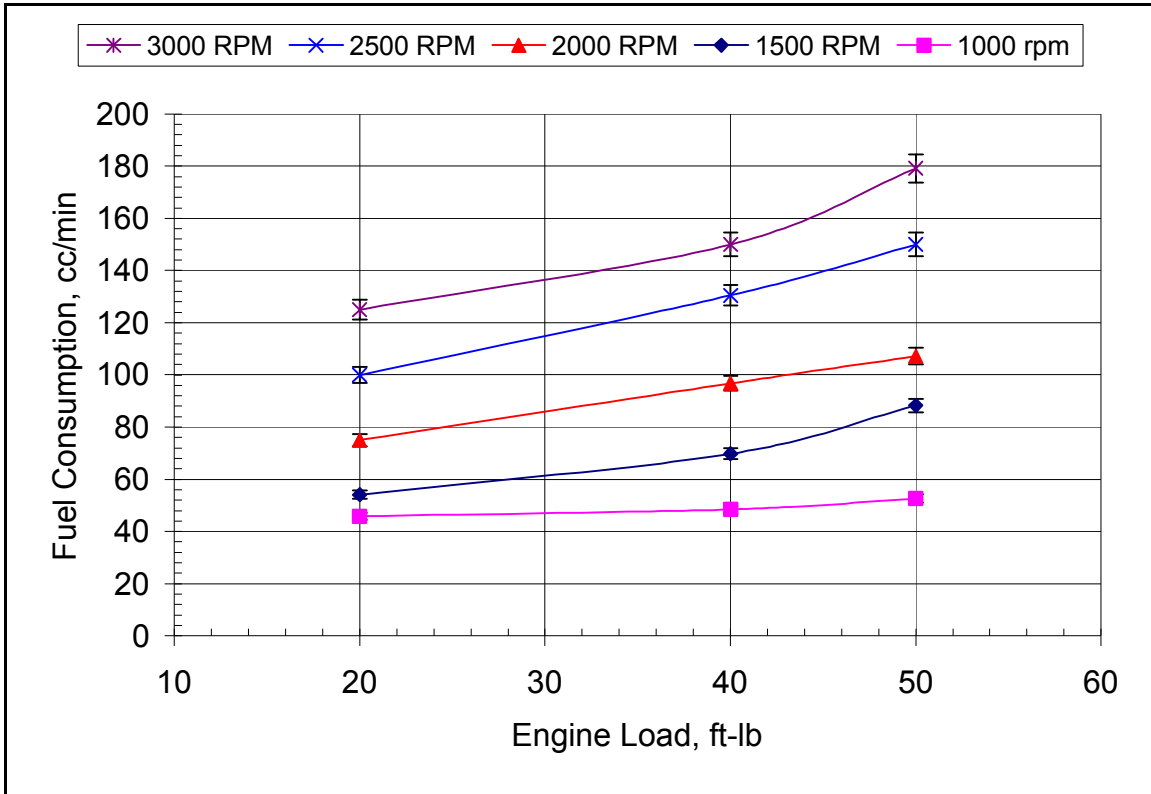
Figure 5. Fuel Consumption as a Function of Engine Load.

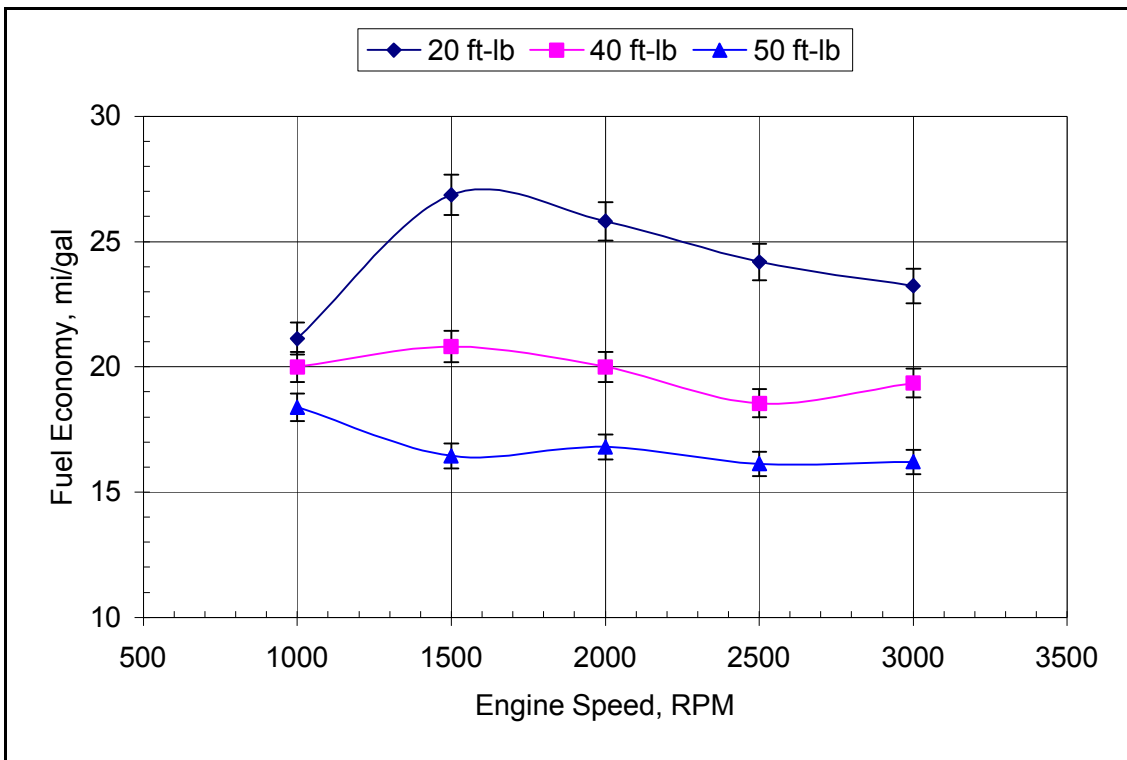
Figure 6. Estimated Fuel Economy of the Engine.

Fig.6. Here an attempt was made to estimate engine's fuel economy in units of miles driven per gallon of fuel consumed (mpg). Arbitrarily a 20 mpg was assumed at 2000 rpm and at an engine torque of 40 ft-lb. Assuming that transmission is set at the highest gear for all load and speed combinations given in the table, miles traveled is proportional to the engine speed. Thus one can calculate fuel economy at any speed using the following equation:

Fig. 6 indicates that engine economy is about flat at higher loads, but, decreasing slightly at low loads when engine speed is increased beyond about 1500 rpm. 3% ($\pm 1.5\%$) error bars are shown on all graphs.
